# TRAFFIC COMMISSION MEETING

May 5, 2021

## AGENDA ITEM #7A

Traffic Signing and Striping  
Improvements - Mulberry Drive  
and Rose Ranch Road  
Intersection

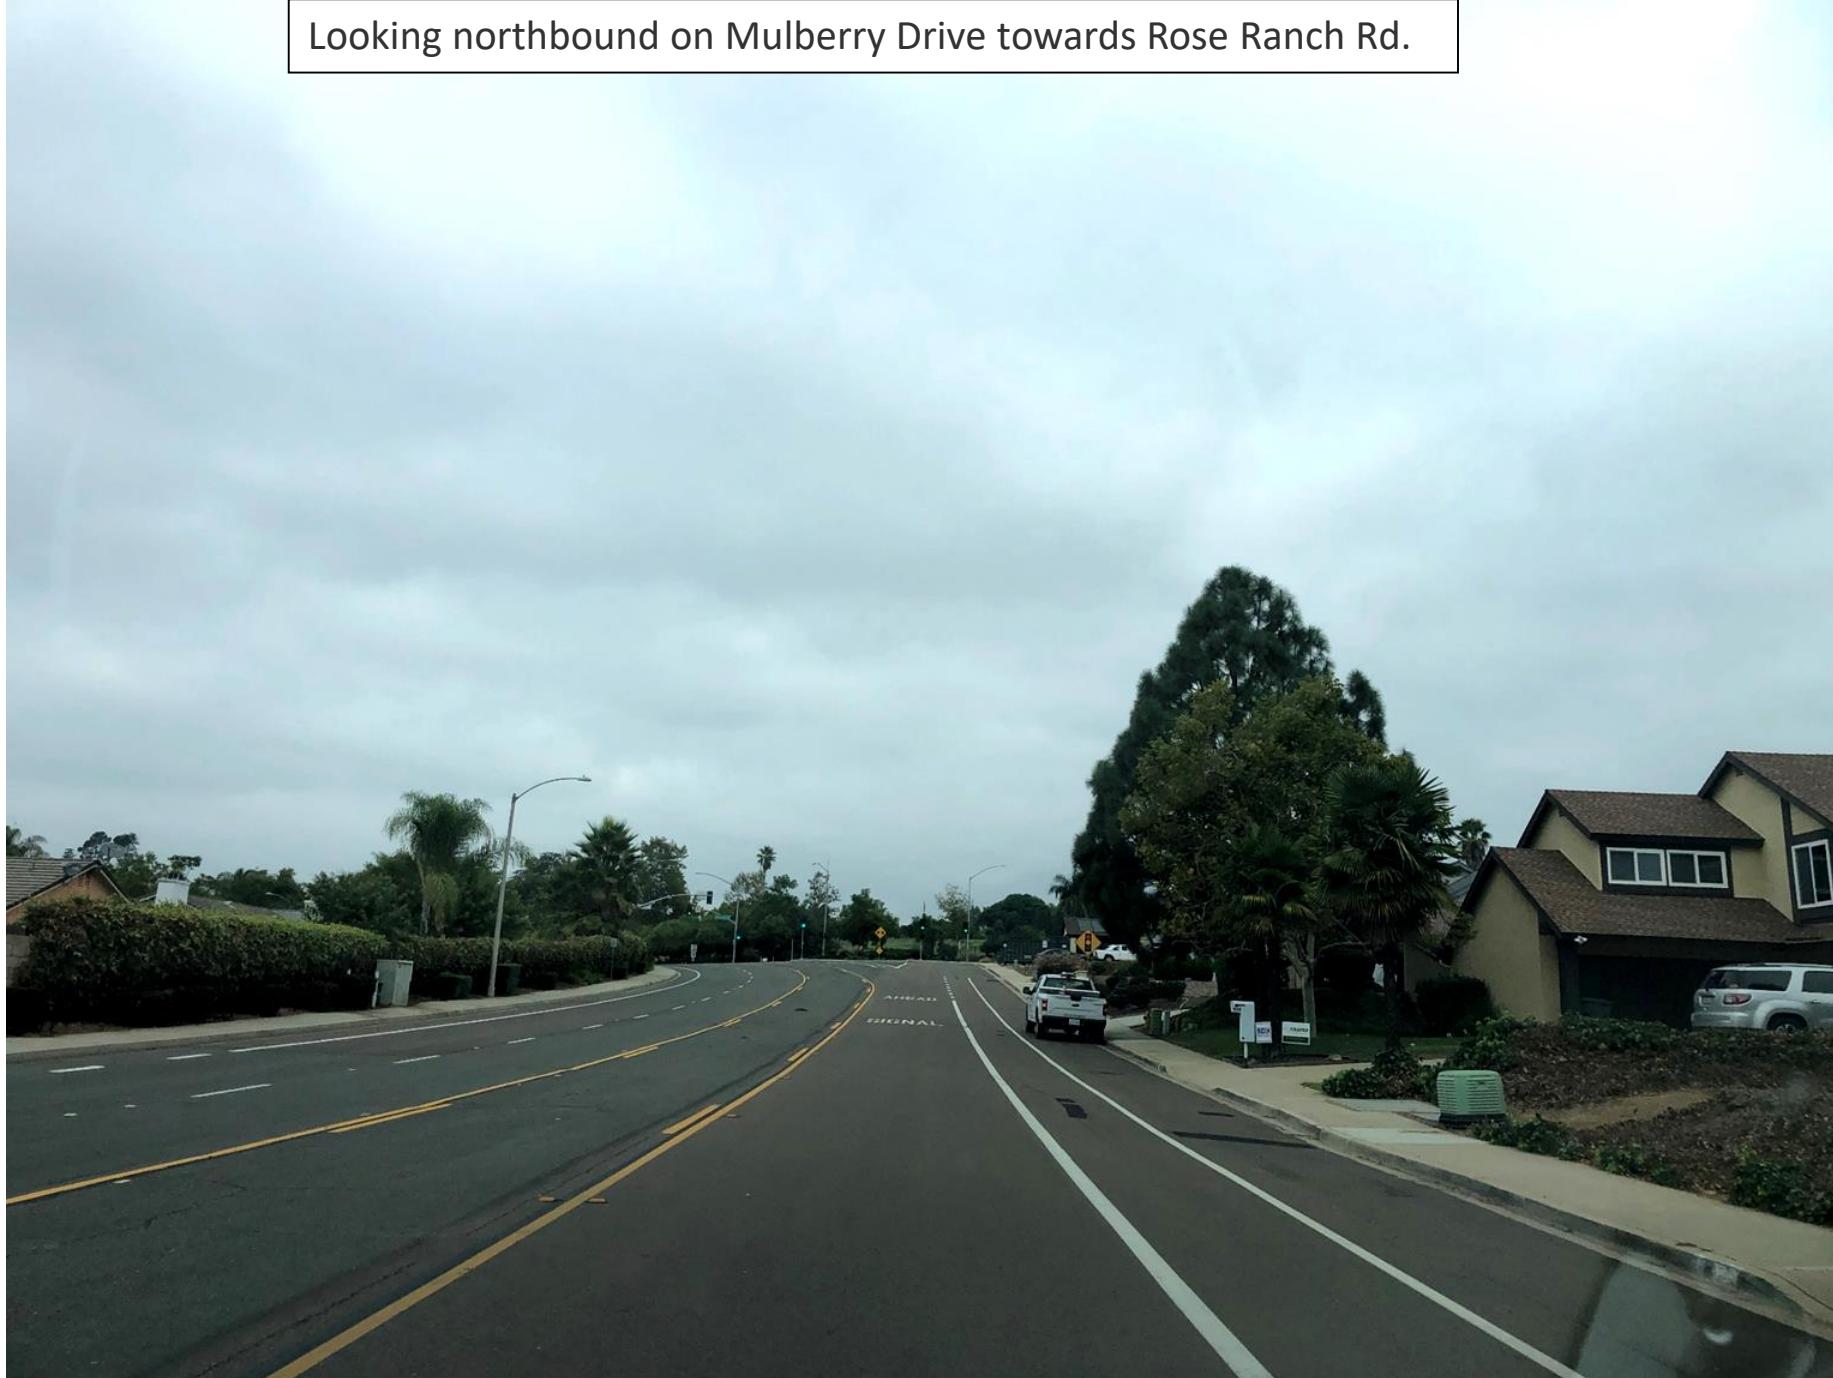
Looking northbound on Mulberry Drive towards Rose Ranch Rd.

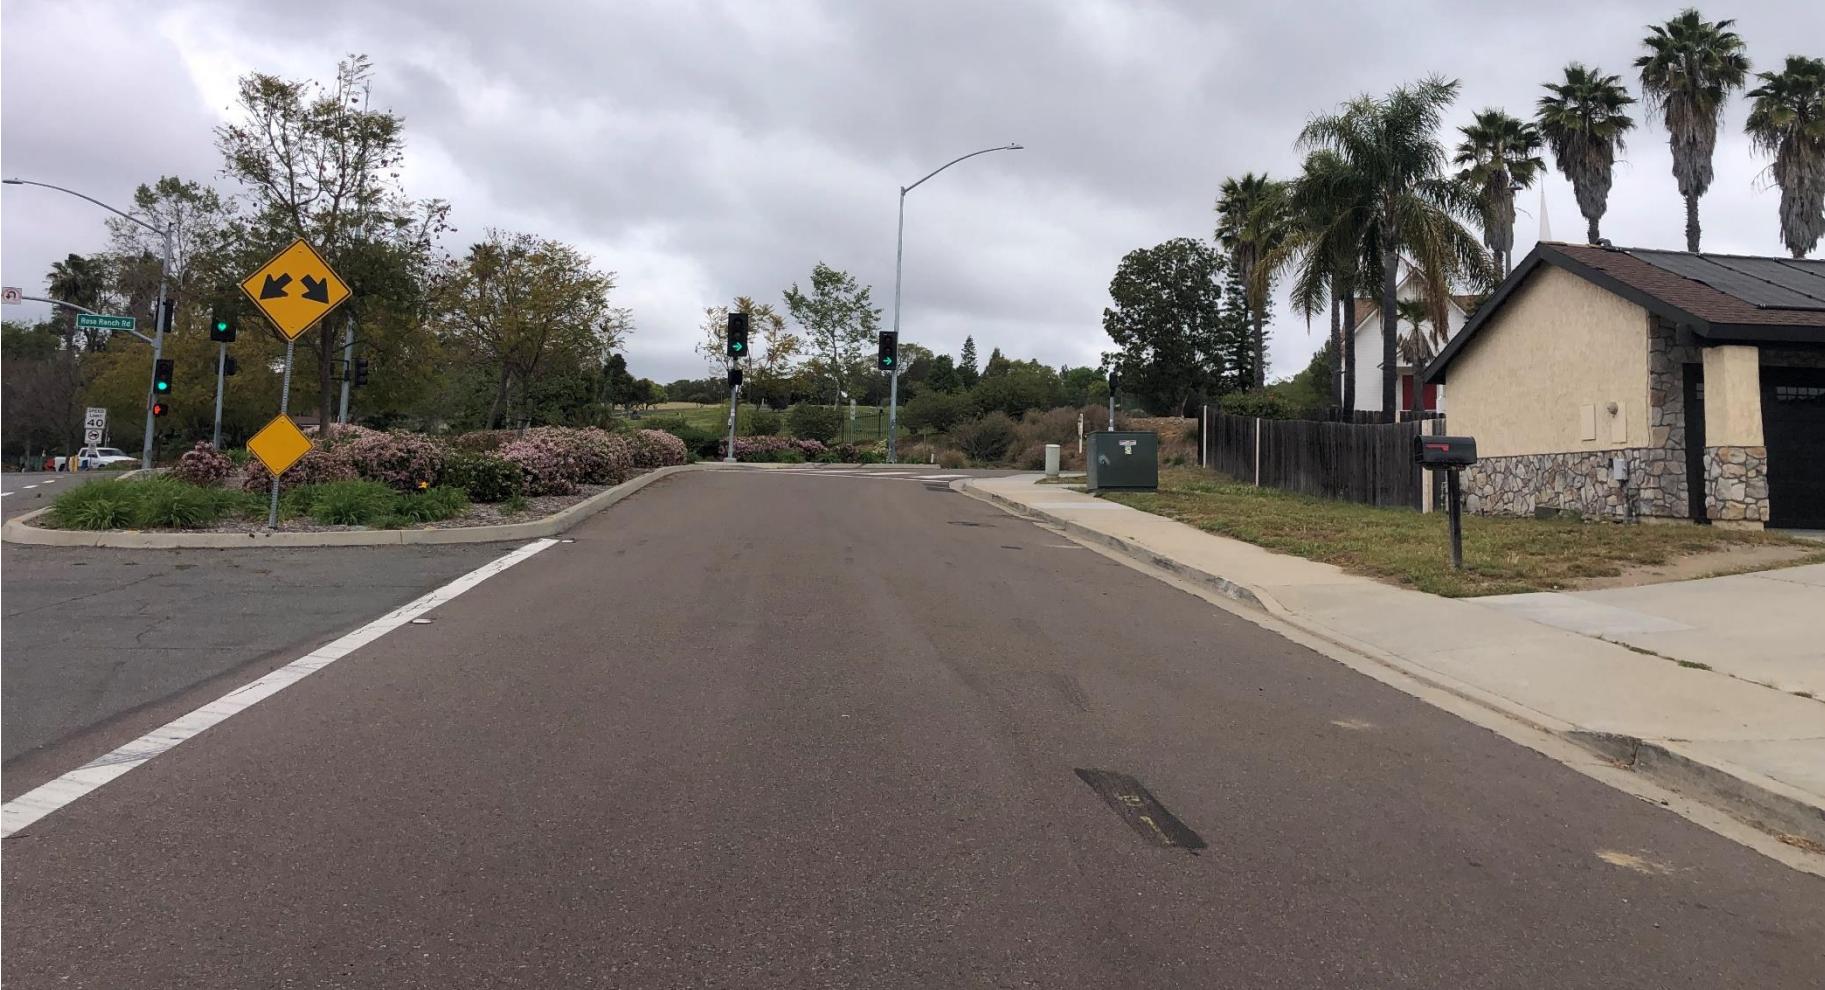
Looking northbound on Mulberry Drive (inside right-turn slip lane).

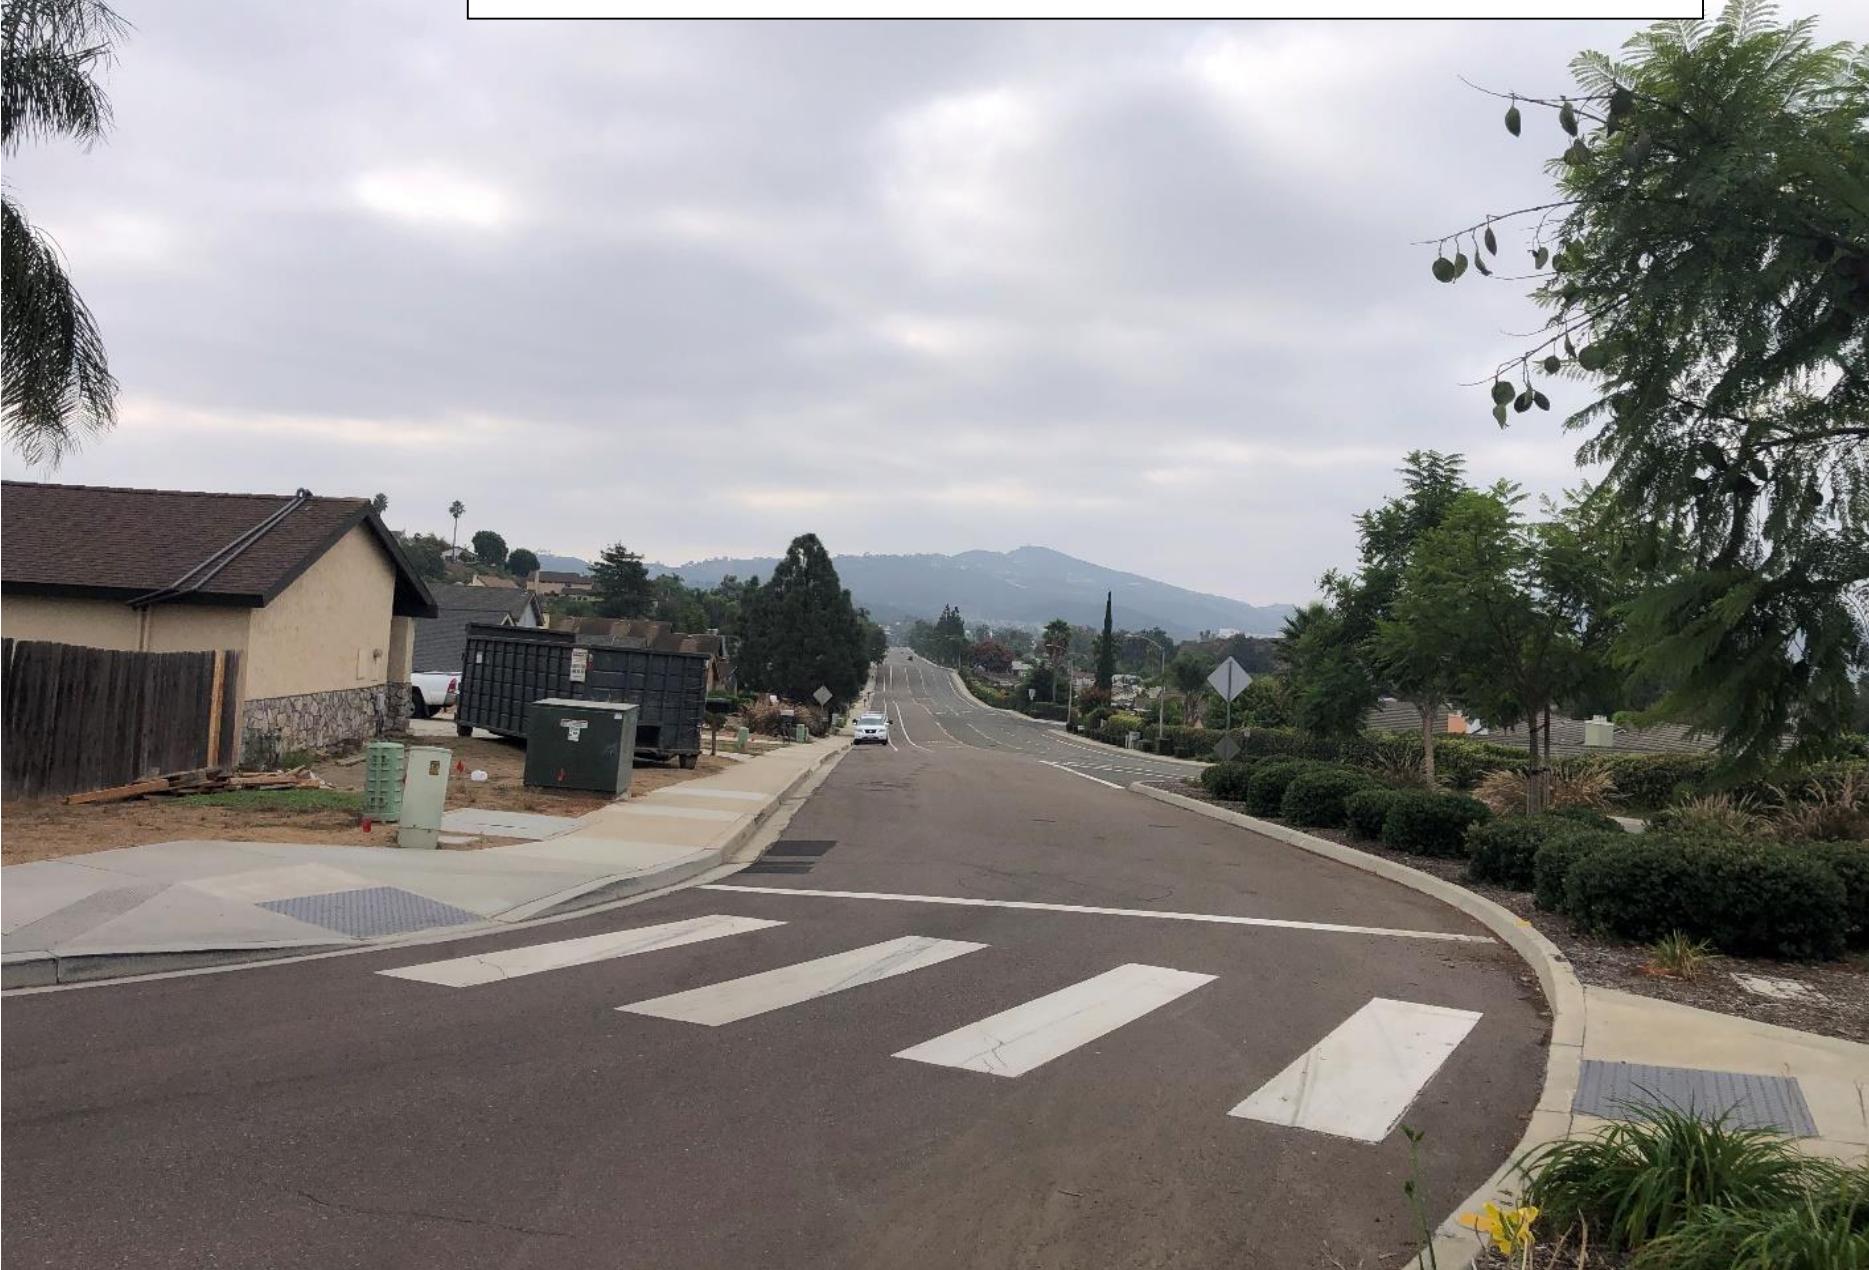
Looking southbound on Mulberry Dr. from right-turn slip lane at traffic signal pole location

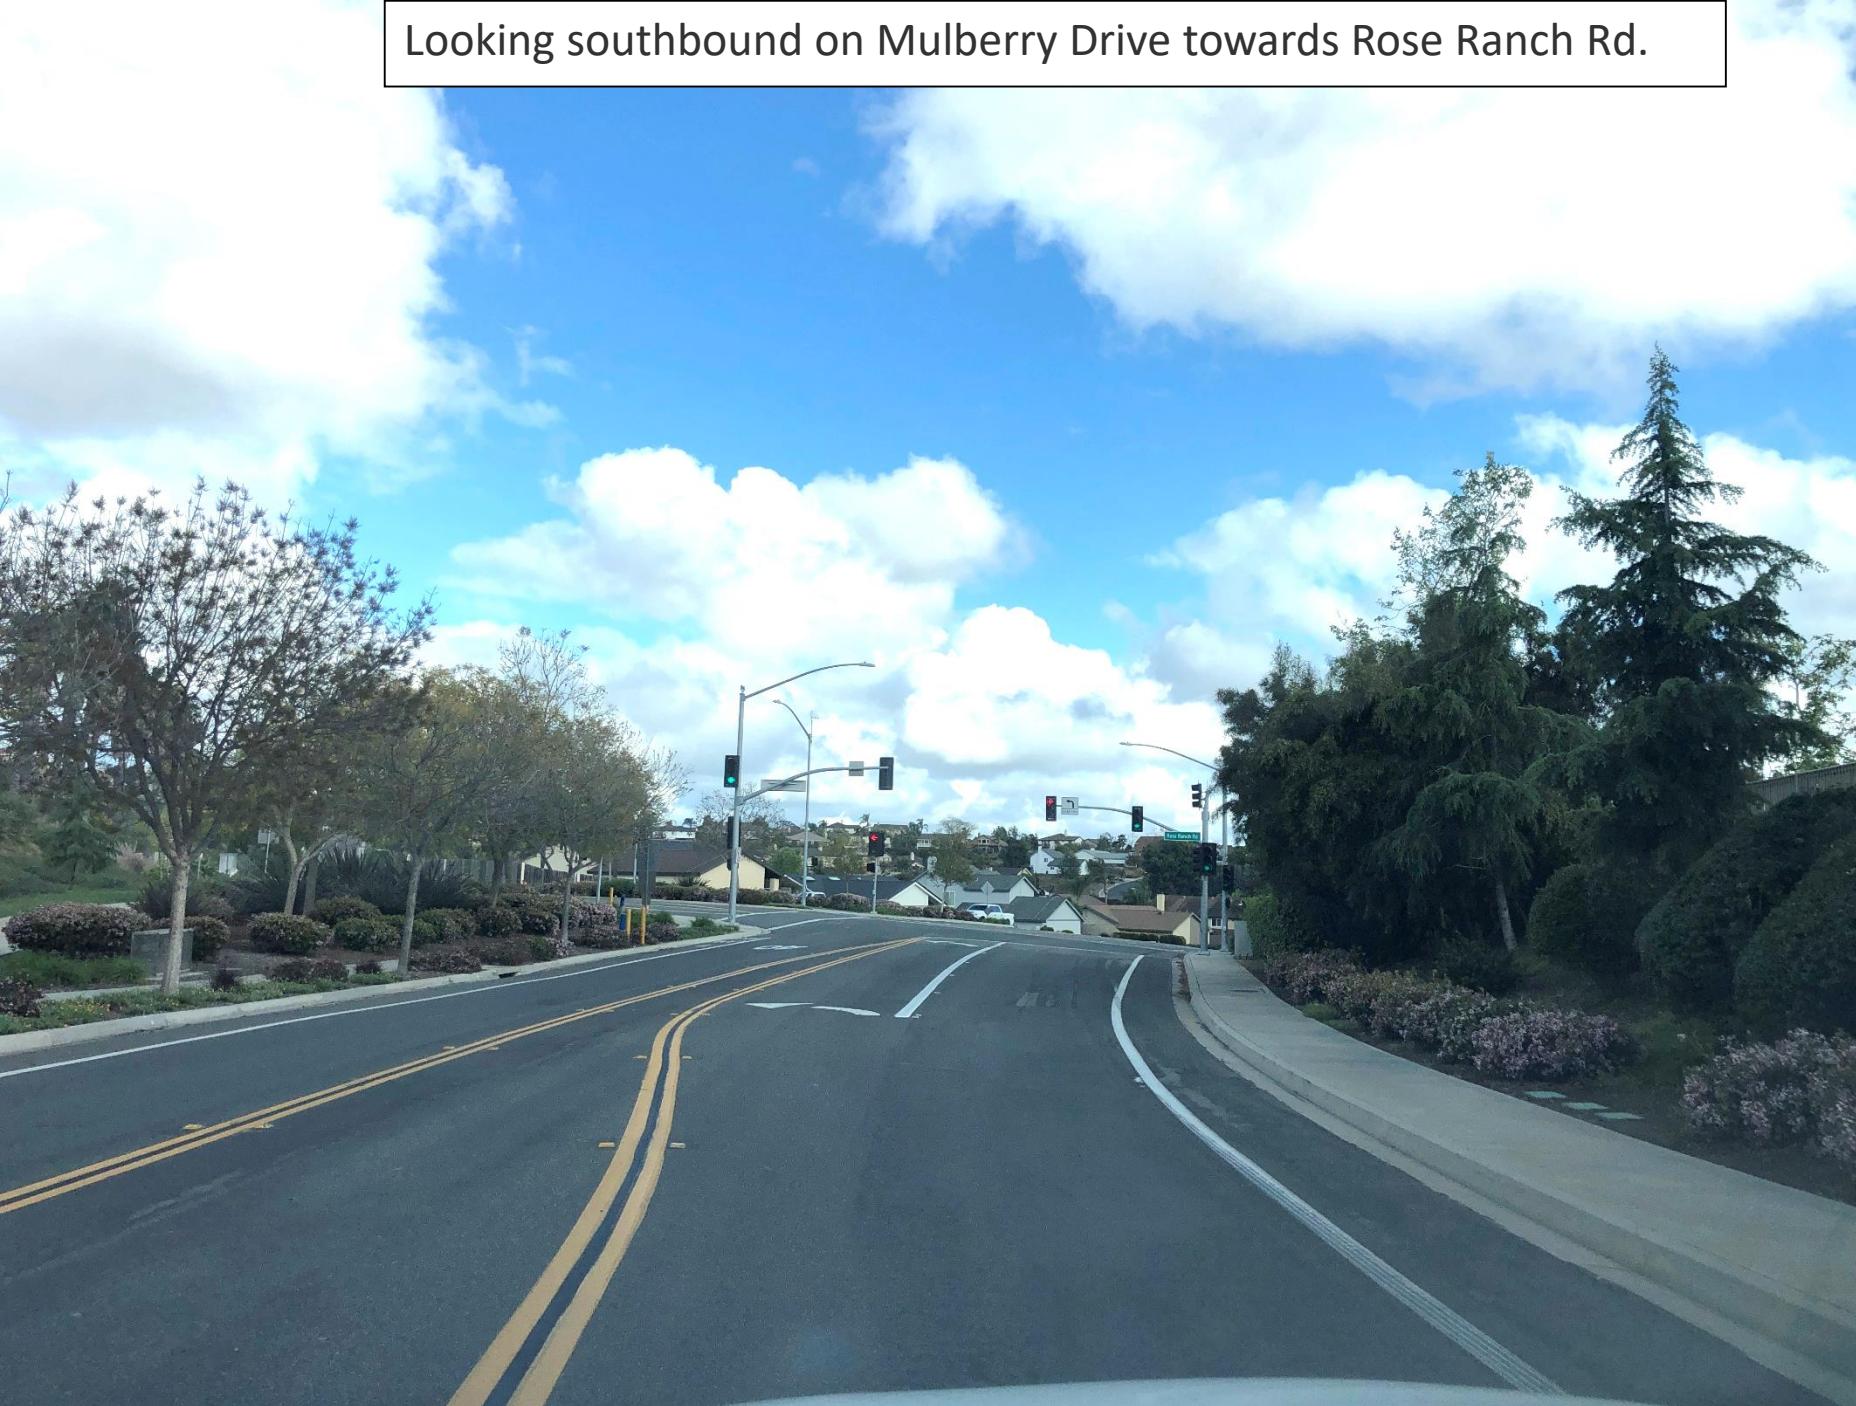
Looking southbound on Mulberry Drive towards Rose Ranch Rd.

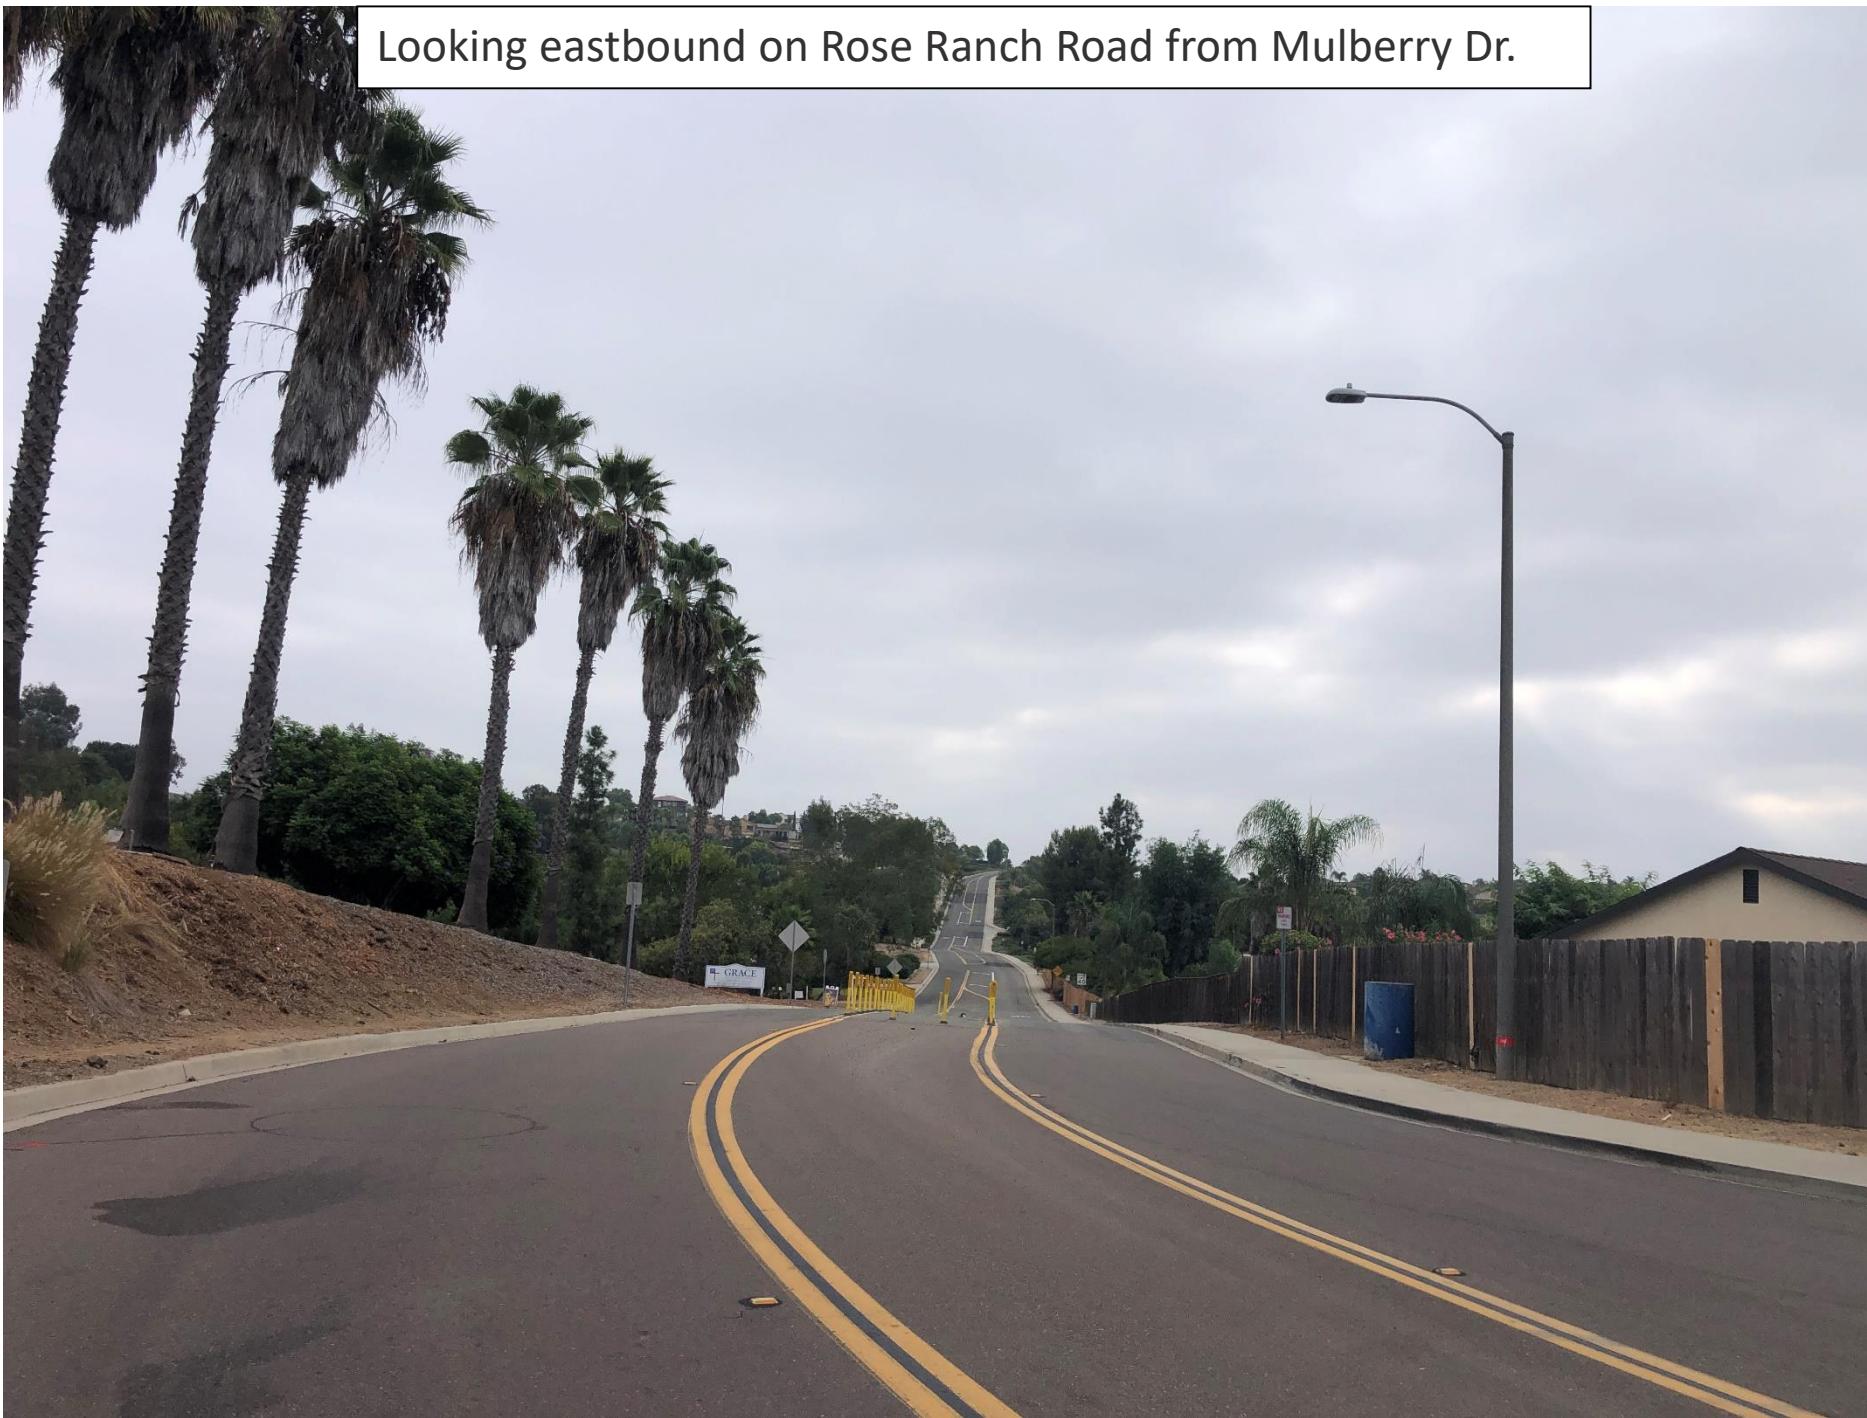
Looking eastbound on Rose Ranch Road from Mulberry Dr.

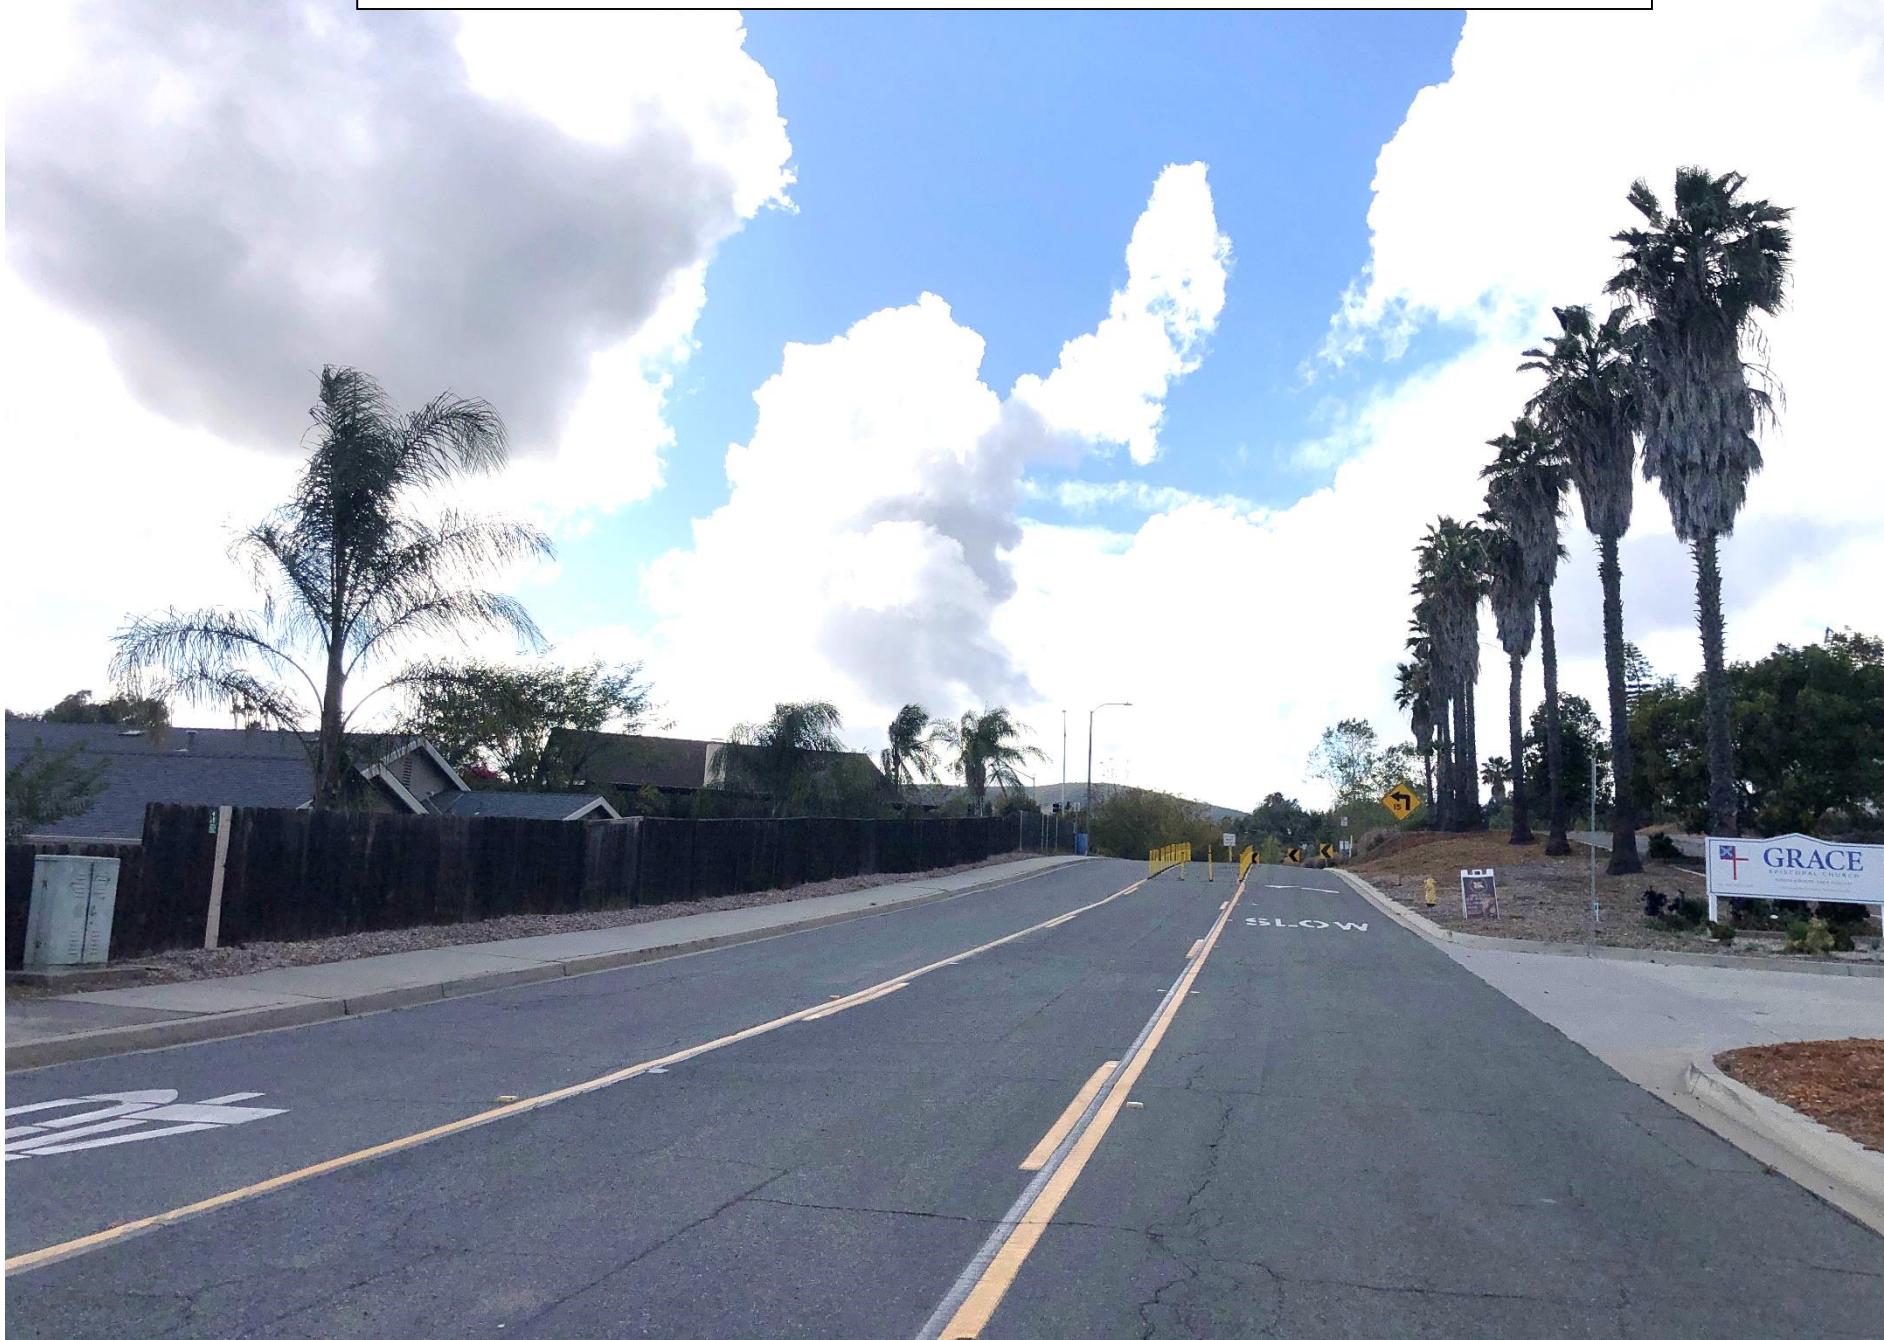
Looking westbound on Rose Ranch Rd. towards Mulberry Dr

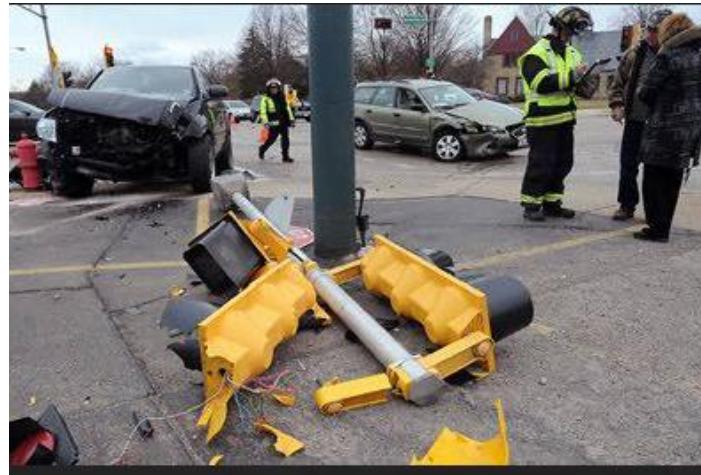
- Engineering staff reviewed the collision history for the last three (3) years and found a total of six “Fixed Object” type collisions, and involved vehicles traveling in the northbound Mulberry Drive direction which resulted in property damage to the existing raised “pork chop” island and/or existing traffic signal poles.
- All reported collisions have been attributed to unsafe speeding, unsafe turning and DUI. There were no collisions that involved pedestrians or bicyclists at the intersection.

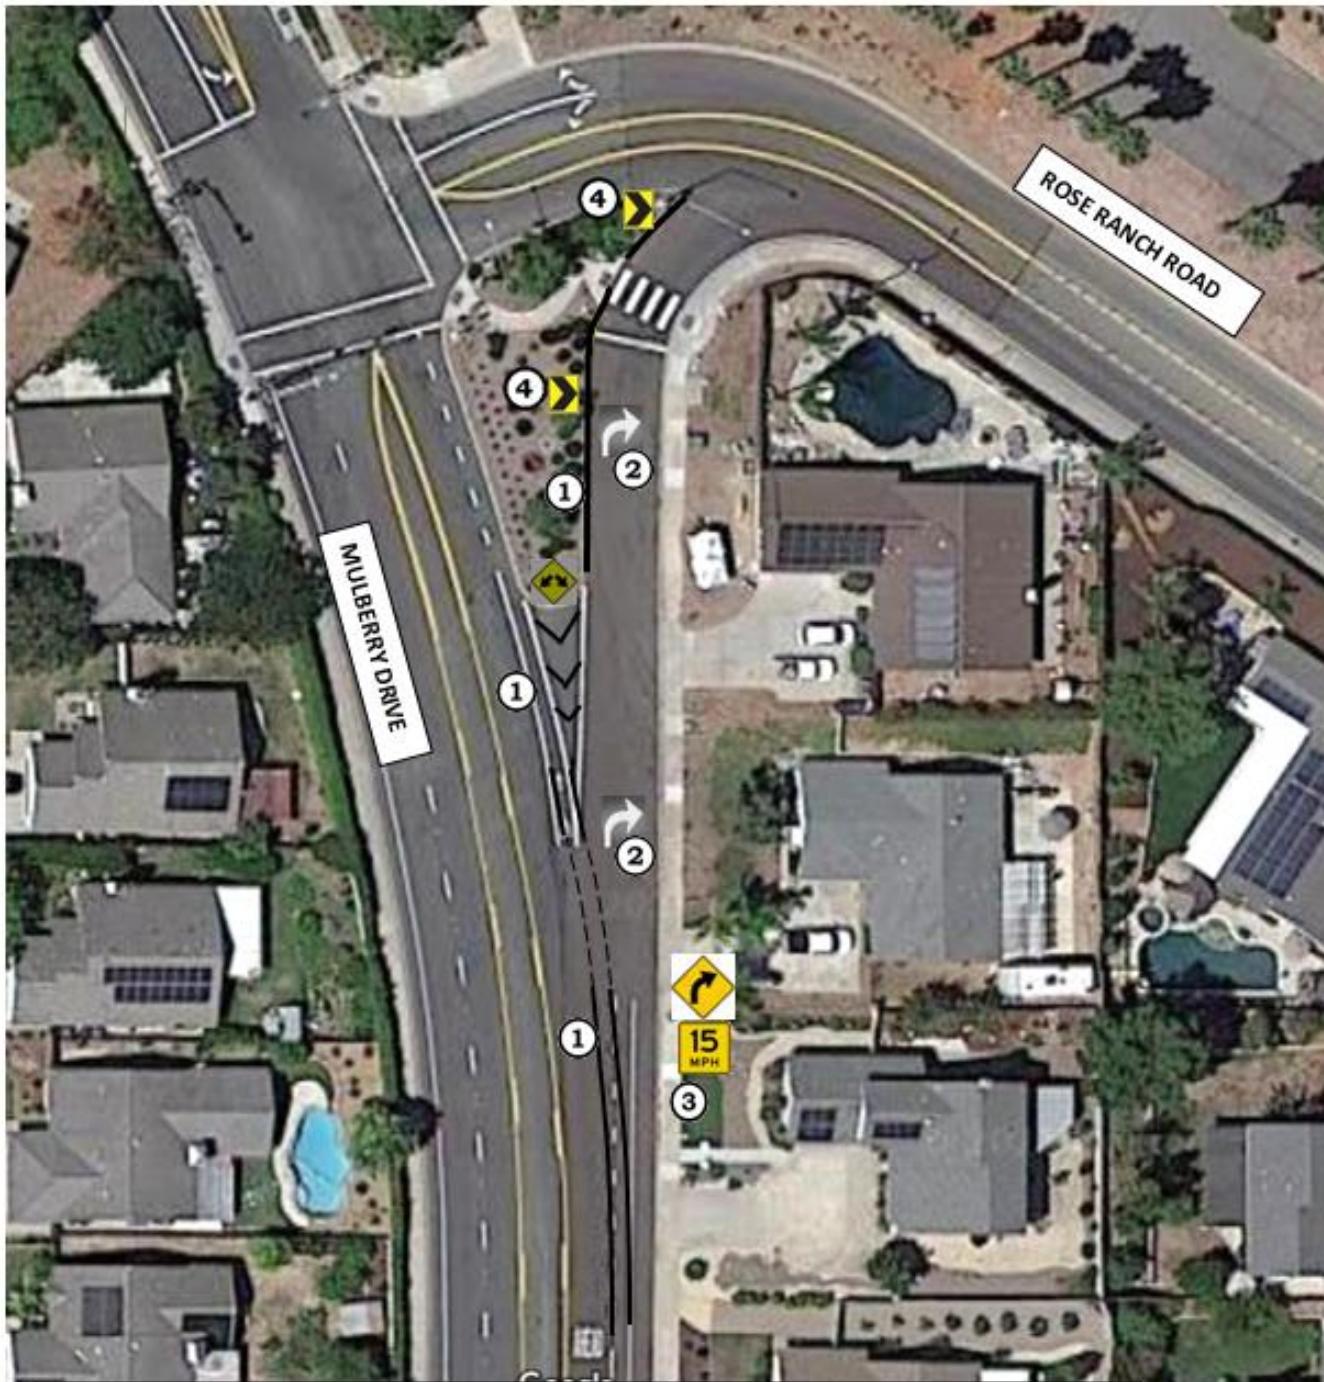
- Based on its field investigation, Engineering staff noted that additional traffic warning signs and pavement markings for the existing right-turn slip lane in accordance with the CAMUTCD (Figure 3B-13) would be beneficial.
- In addition, motorists traveling on northbound Mulberry Drive could benefit from additional guidance on which lane to take for eastbound Rose Ranch Road.
- Therefore, Engineering staff recommends additional traffic signing and striping improvements consistent with CAMUTCD standards as low-cost effective countermeasures for reducing vehicular speeds, increasing speed awareness, and enhancing visibility of the intersection.
- Similarly, westbound Rose Ranch Road towards Mulberry Drive has additional curve warning signs and pavement markings that inform motorists of the upcoming curved roadway section.

- Engineering staff recommends traffic signing and striping improvements be installed at the intersection of Mulberry Drive and Rose Ranch Road to include the following:

- 1) A five-foot bike lane extended through the right-turn slip lane on northbound Mulberry Drive to assist in channelizing vehicular through traffic.
- 1) Installation of painted gore area to separate traffic for northbound Mulberry Drive from the existing right-turn slip lane.
- 1) Installation of left edgeline (yellow) adjacent to the raised "porkchop" island to improve visibility of the limit of travel way.
- 2) Installation of new right turn pavement arrows in the right-turn slip lane.
- 3) Installation of new advance curve warning sign with a supplementary 15-MPH speed advisory plaque.
- 4) Installation of new curve alignment warning signs "Chevrons" to delineate the curved raised island and roadway.
