TRAFFIC COMMISSION MEETING

June 2, 2021

AGENDA ITEM #7A

“NO TURN ON RED” sign- San Elijo Rd/Twin Oaks Valley Rd and Equestrian Court/Double Peak K-8 School Driveway

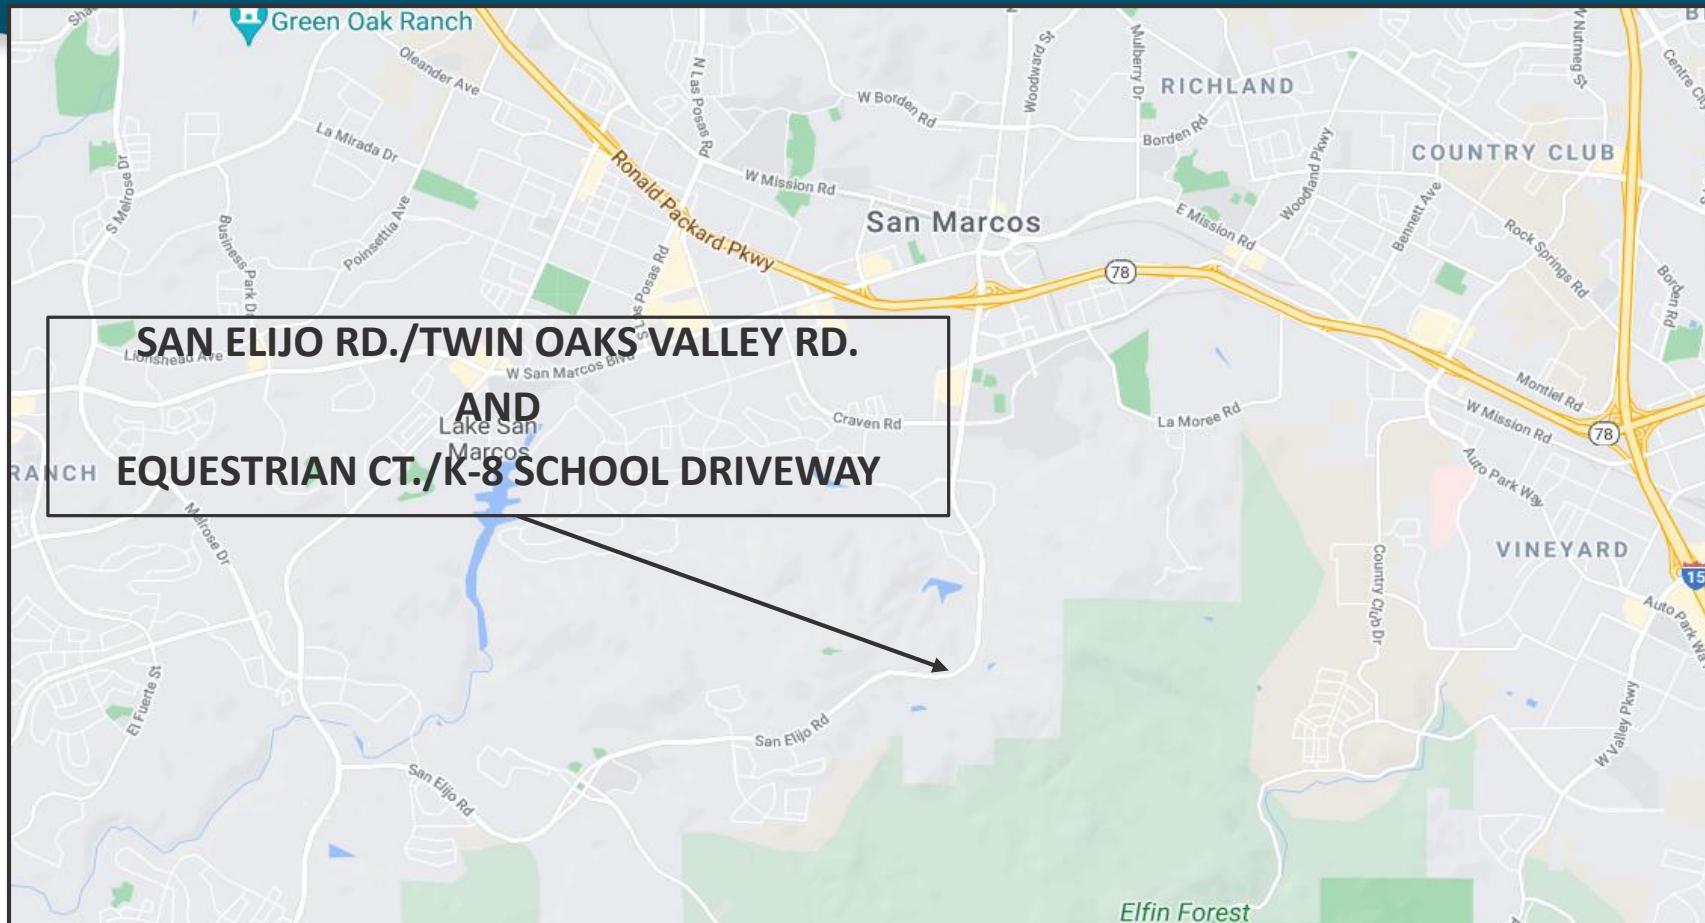
- VICINITY MAP
- “NO TURN ON RED” SIGN
- AGENDA ITEM #7A-JUNE 2, 2021

- Study area – Signalized intersection of San Elijo Rd/Twin Oaks Valley Rd @ Equestrian Court/Double Peak K-8 School Driveway
- Southern part of the City

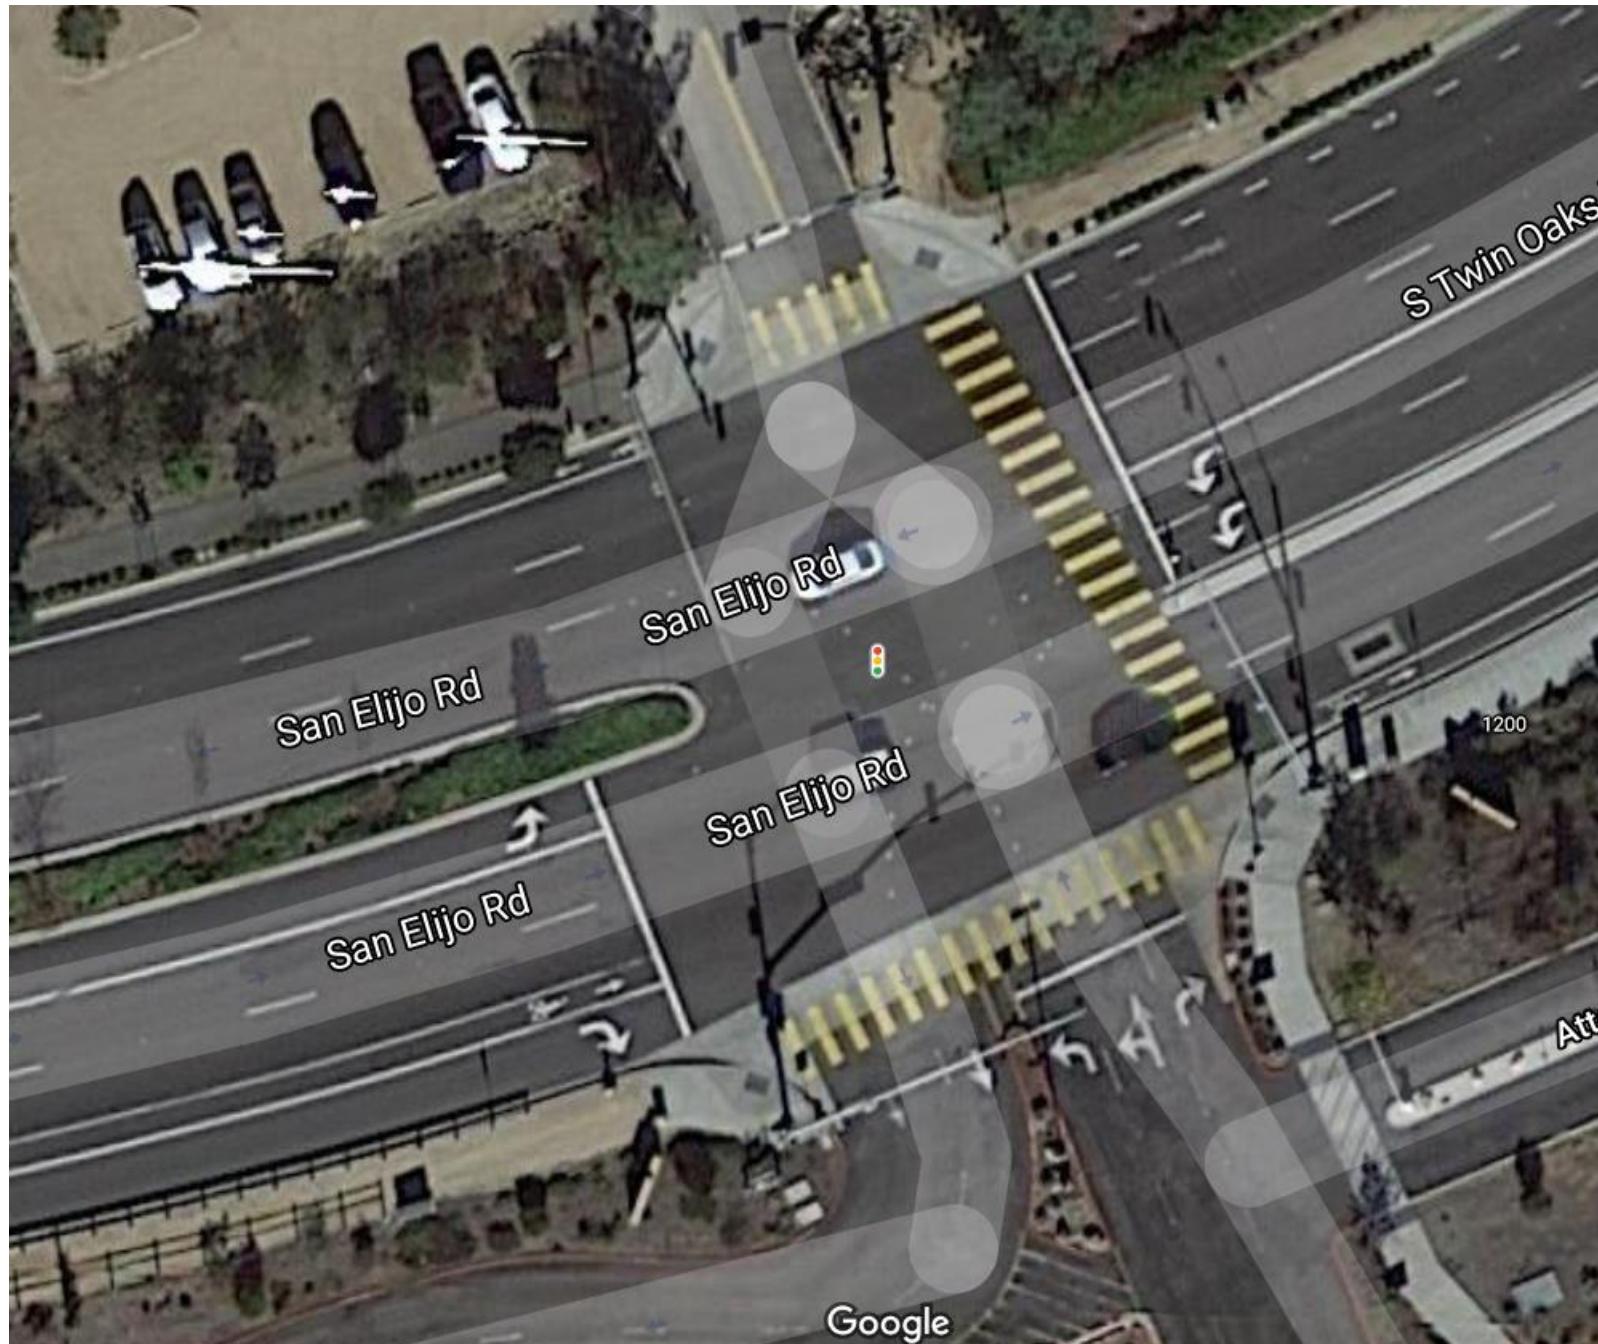
- San Elijo Rd/Twin Oaks Valley Rd (Major Arterial) - (3) lanes in WB direction, (2) lanes in EB direction.
- Posted speed limit - 45 MPH
- Street grade approx. 8% in the vicinity of this intersection.
- Equestrian Ct/Double Peak School approaches are single lane
- Due to restricted line of sight, blank-out signs are posted on both Equestrian Dr and the Double Peak K-8 Driveway
- Pedestrian crossings are marked on all legs except the west leg
- A six-phase traffic signal operation w/north-south split.

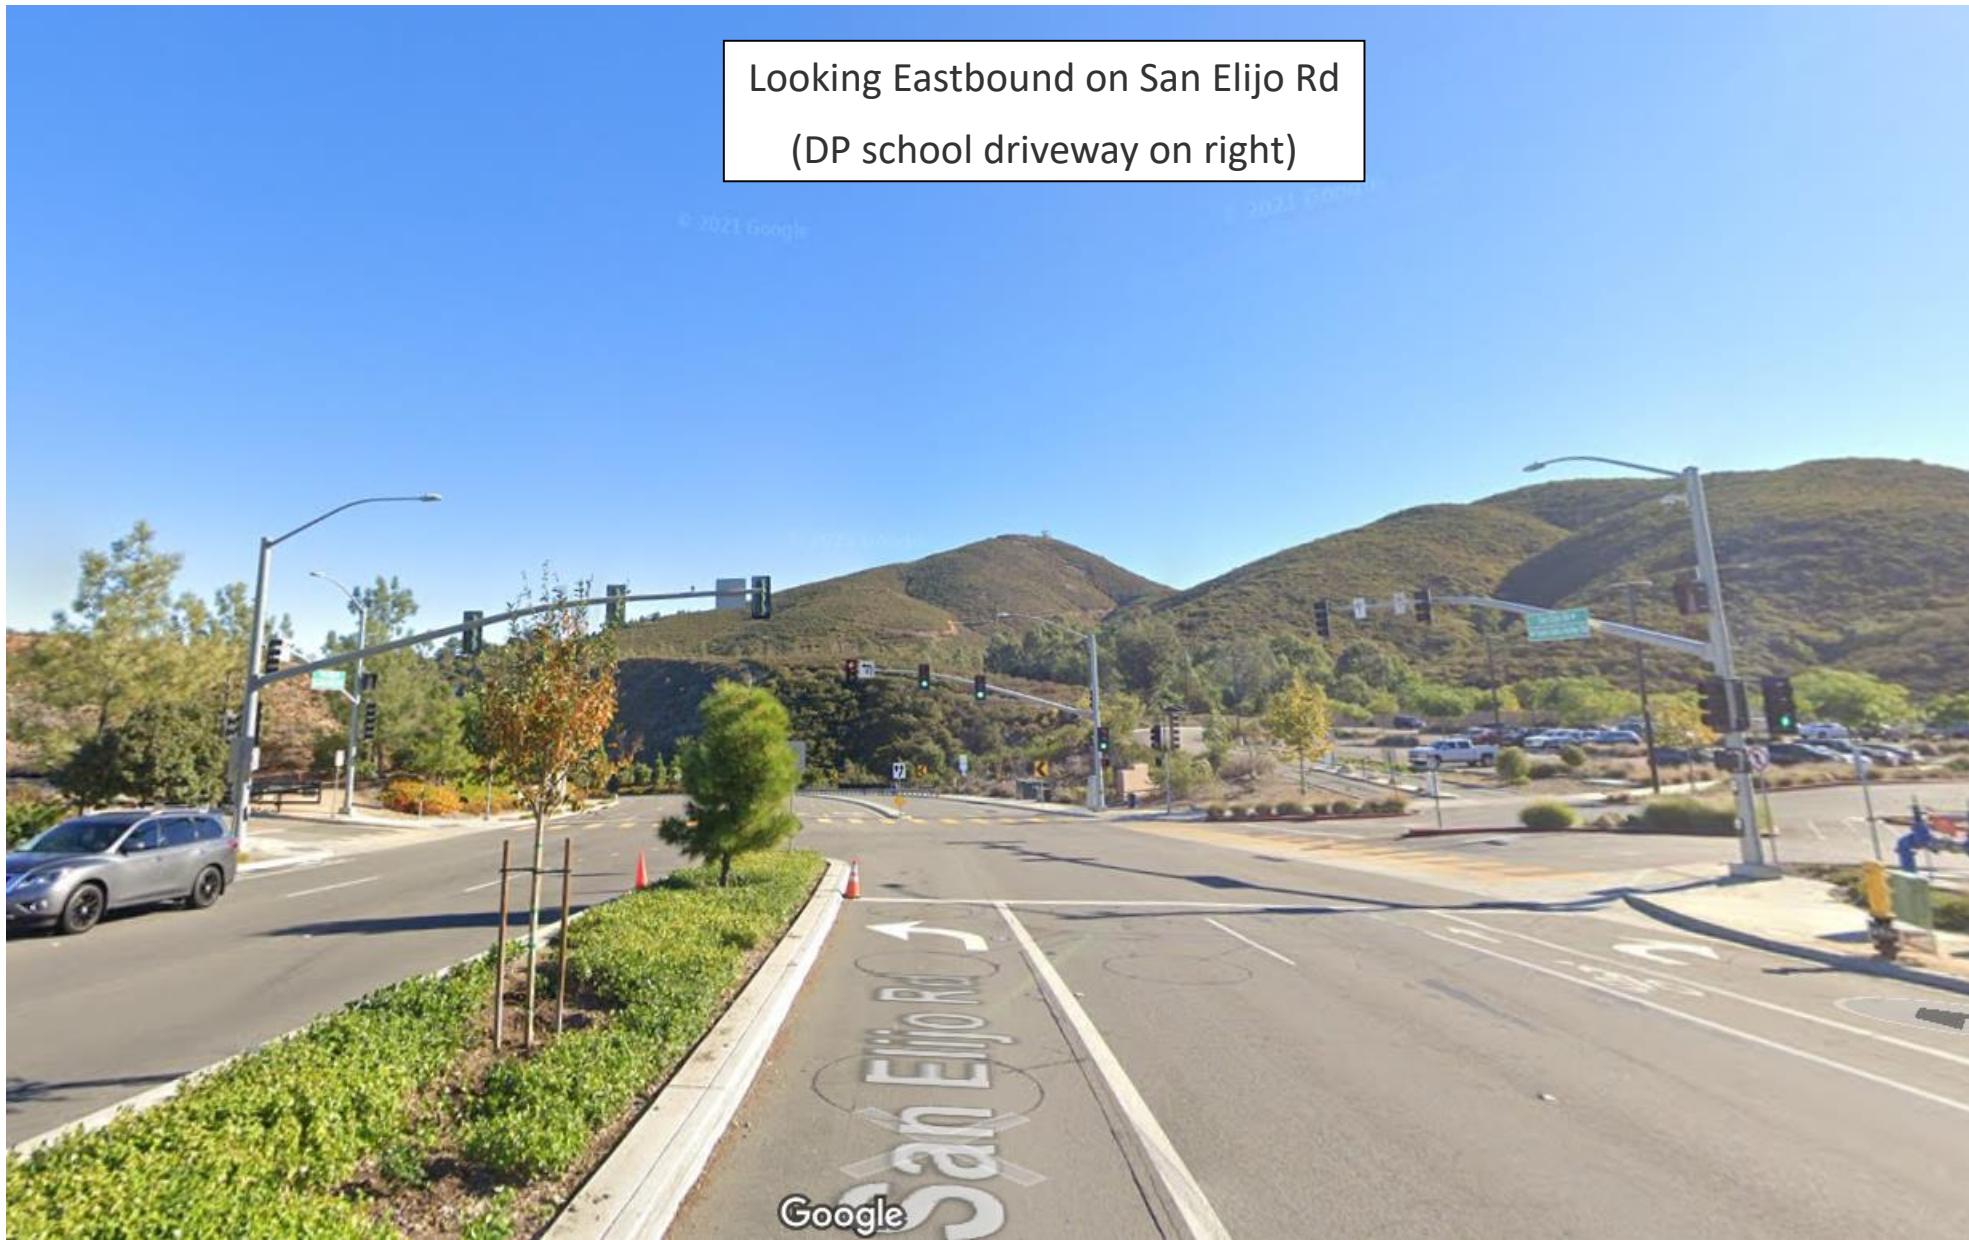
Looking Eastbound on San Elijo Rd
(DP school driveway on right)

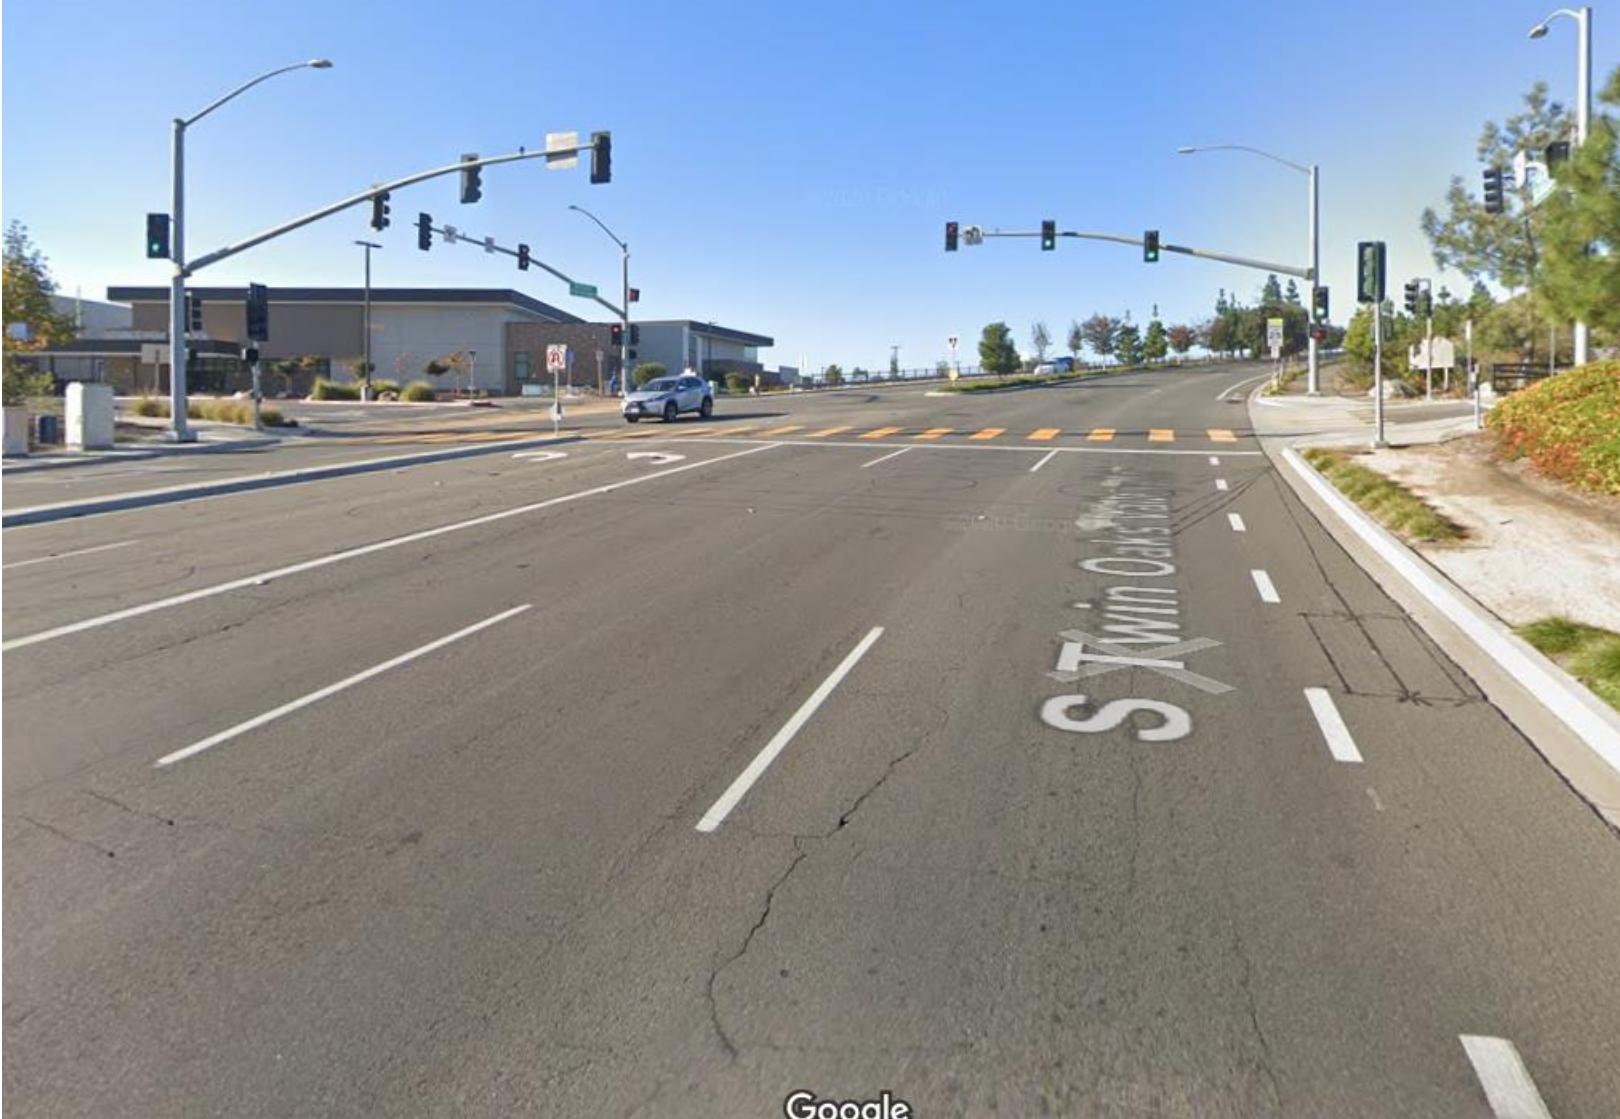
Looking westbound on Twin Oaks Valley Rd

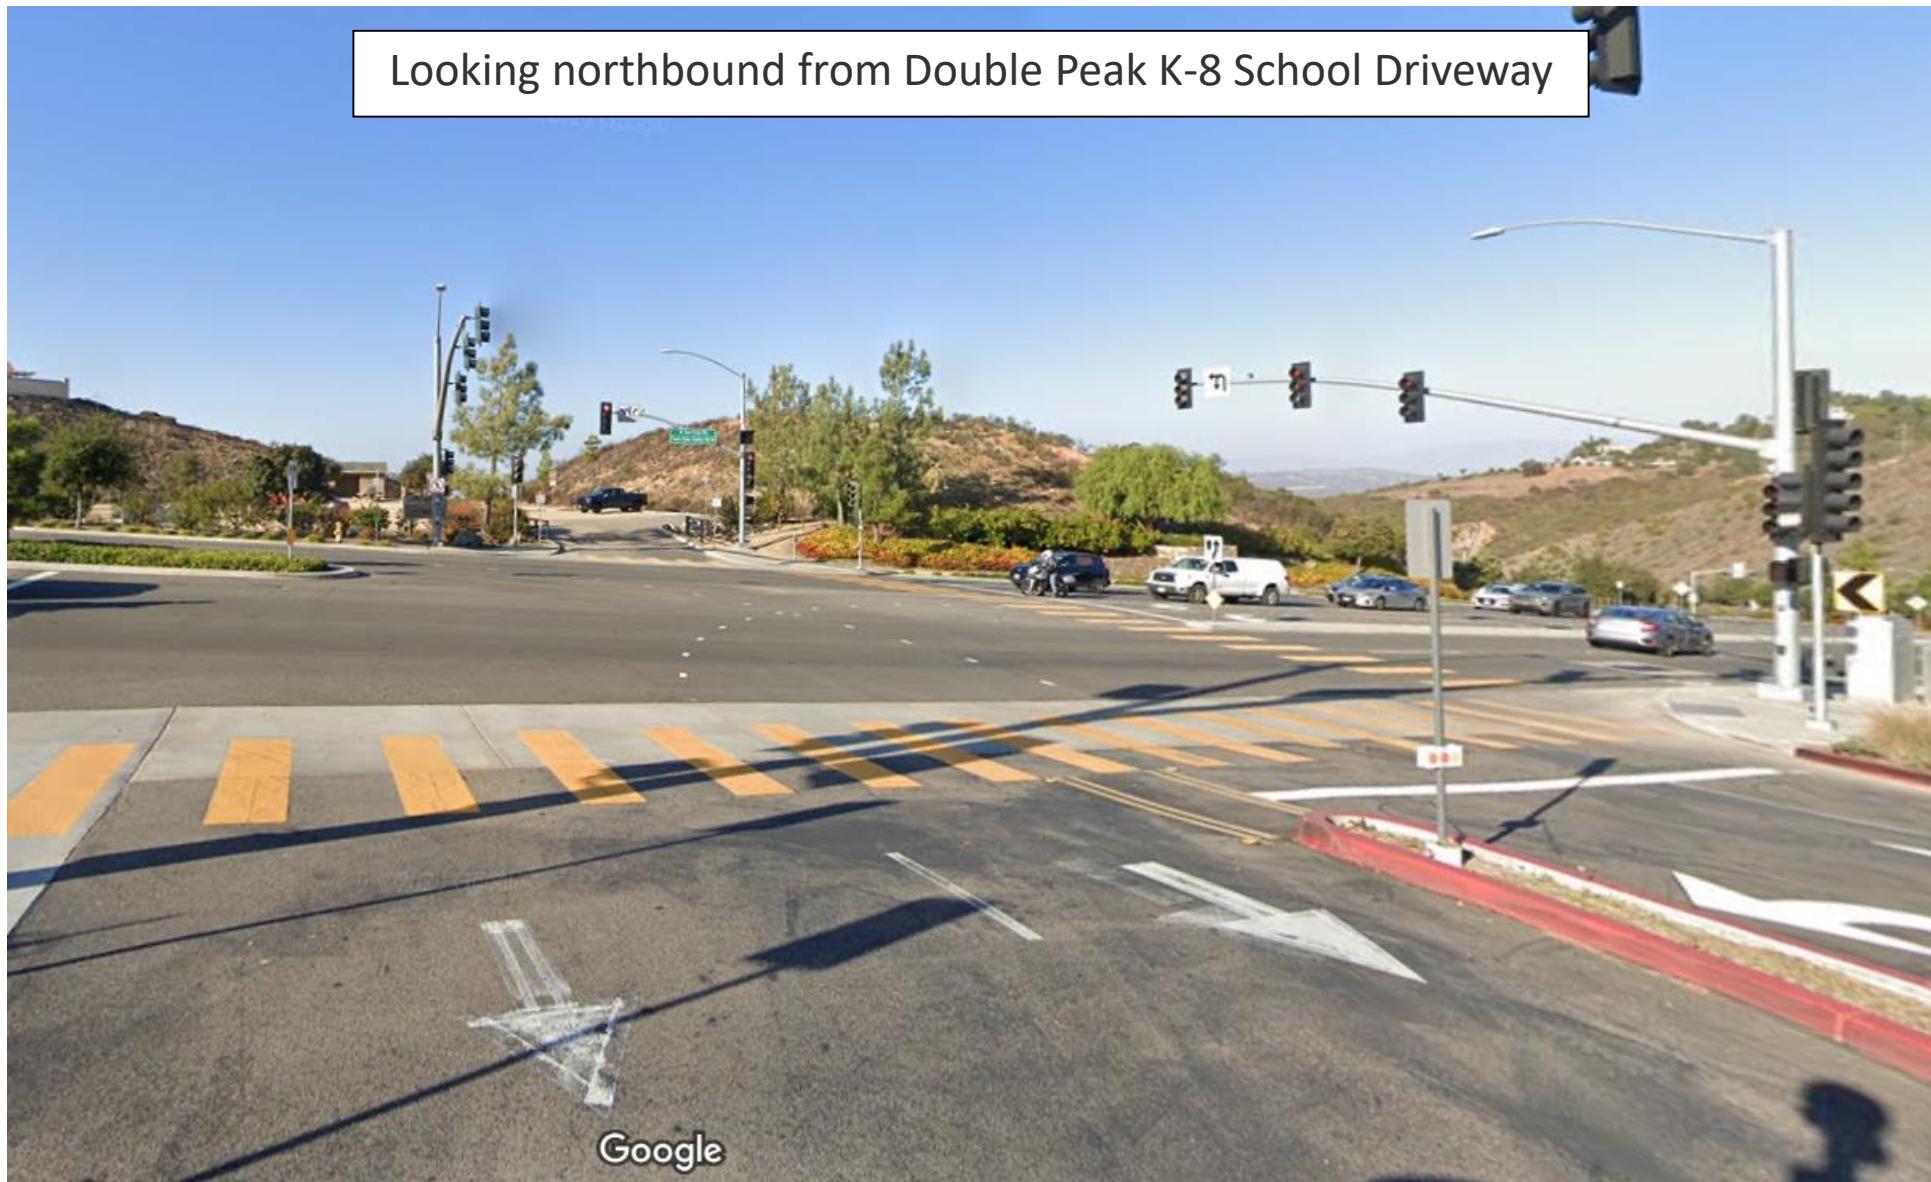
Looking northbound from Double Peak K-8 School Driveway

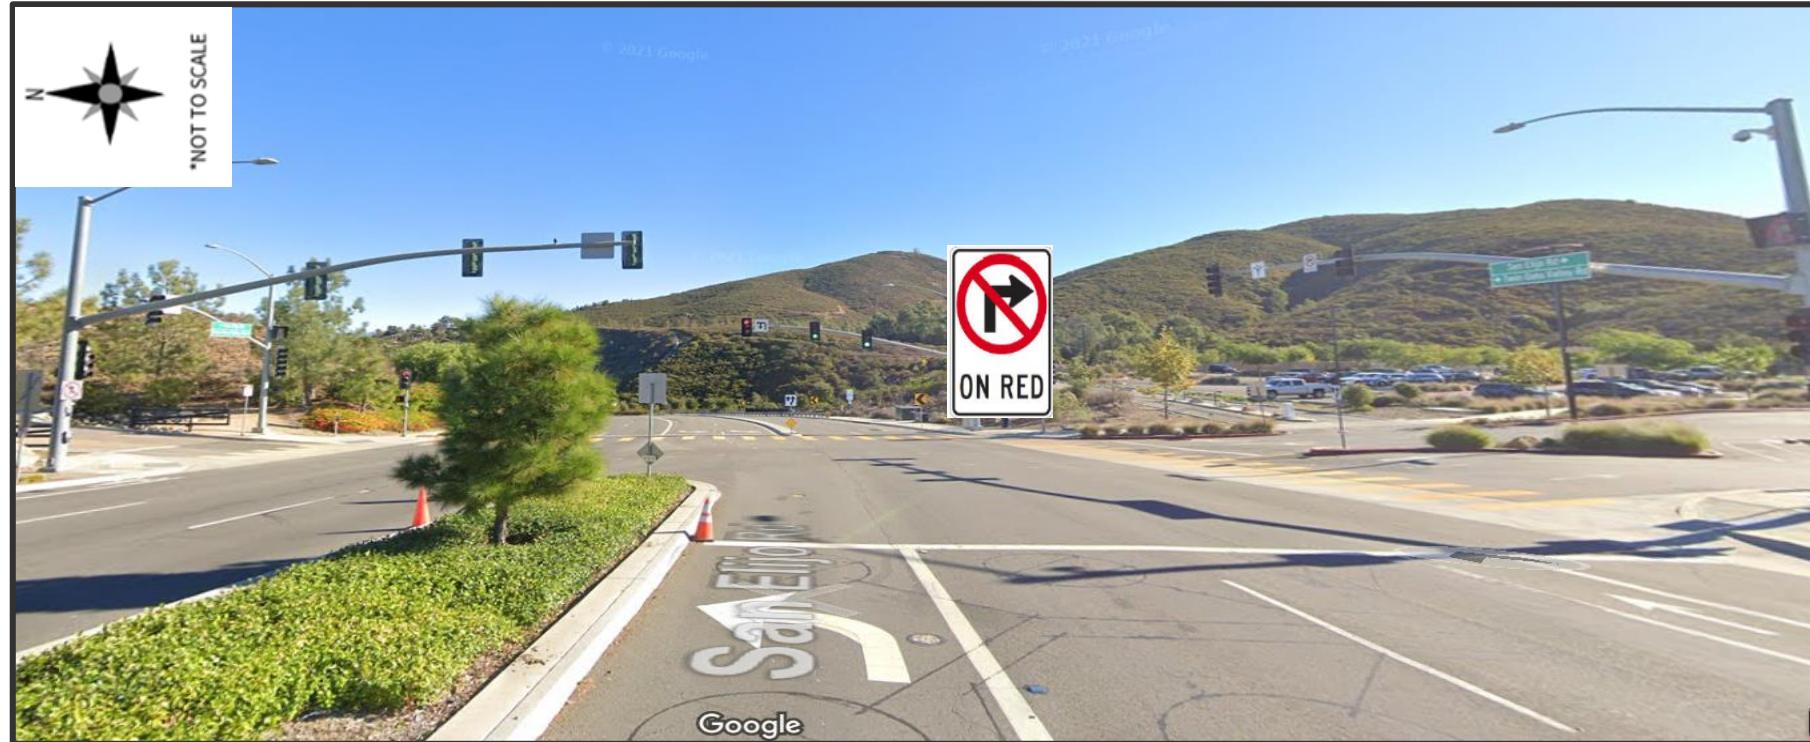
**“NO TURN ON RED SIGN” ON A SIGNAL POLE ON EAST LEG
FACING EASTBOUND TRAFFIC**

- Based on current condition, CAMUTCD criteria (b) and (d) for “No turn on Red” (NTOR) sign are justified.
- The NTOR sign is recommended to be installed on the far signal pole of the intersection and to be oversized (36”X48”) for better visibility (as shown on next slide).
- Intermittent enforcement of this regulatory sign by the Sheriff’s Department will be requested for the sign to be effective.
- Engineering staff continues to work with School District toward expanding the available queuing area to include the parking lot, in order to accommodate a larger volume of queued vehicles on premises and avoid spillback outside of the school driveway during pick-up and drop-off times.

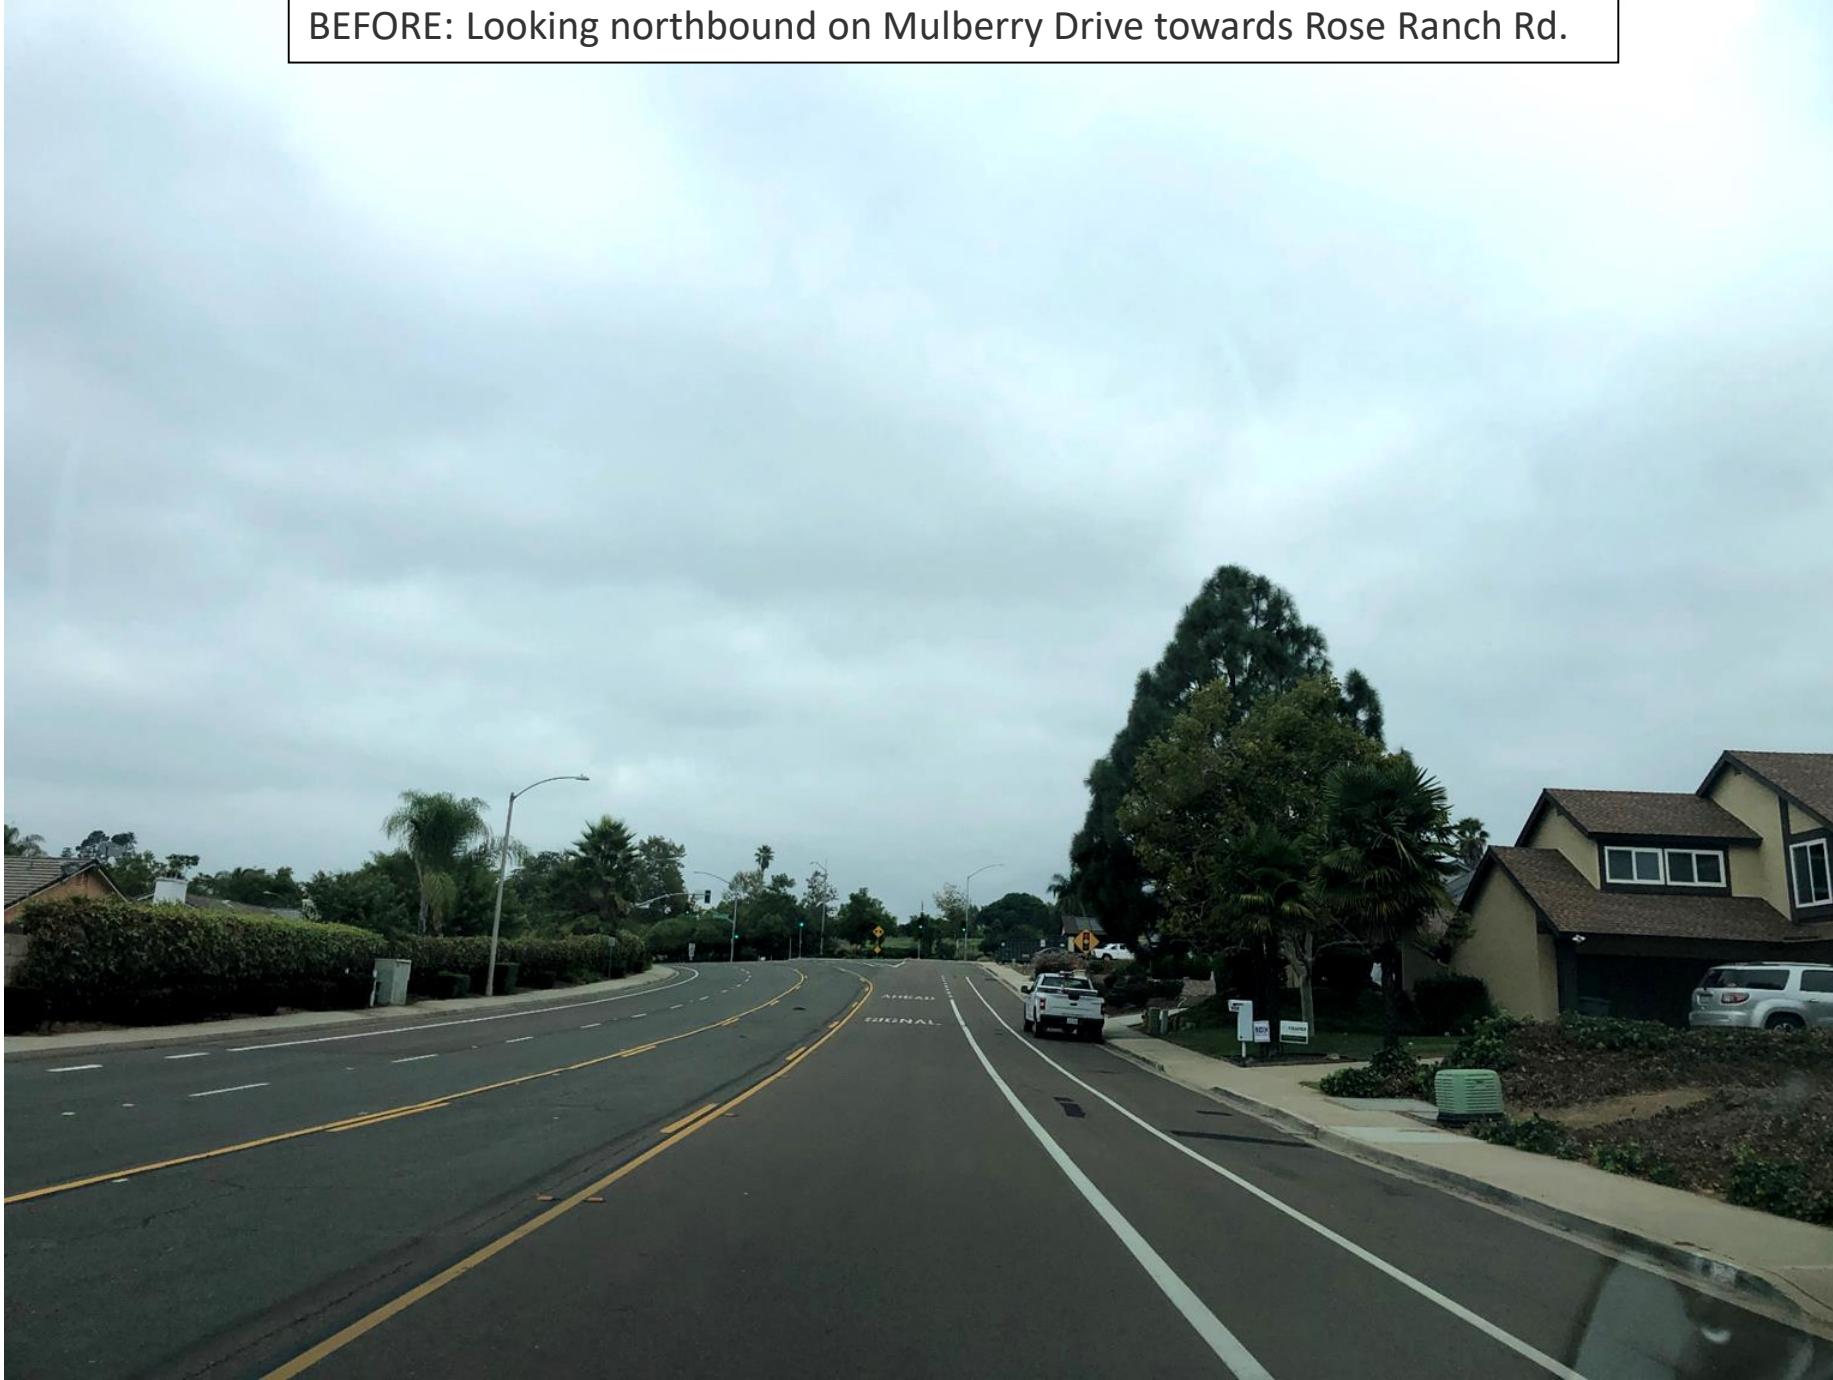
BEFORE: Looking northbound on Mulberry Drive towards Rose Ranch Rd.

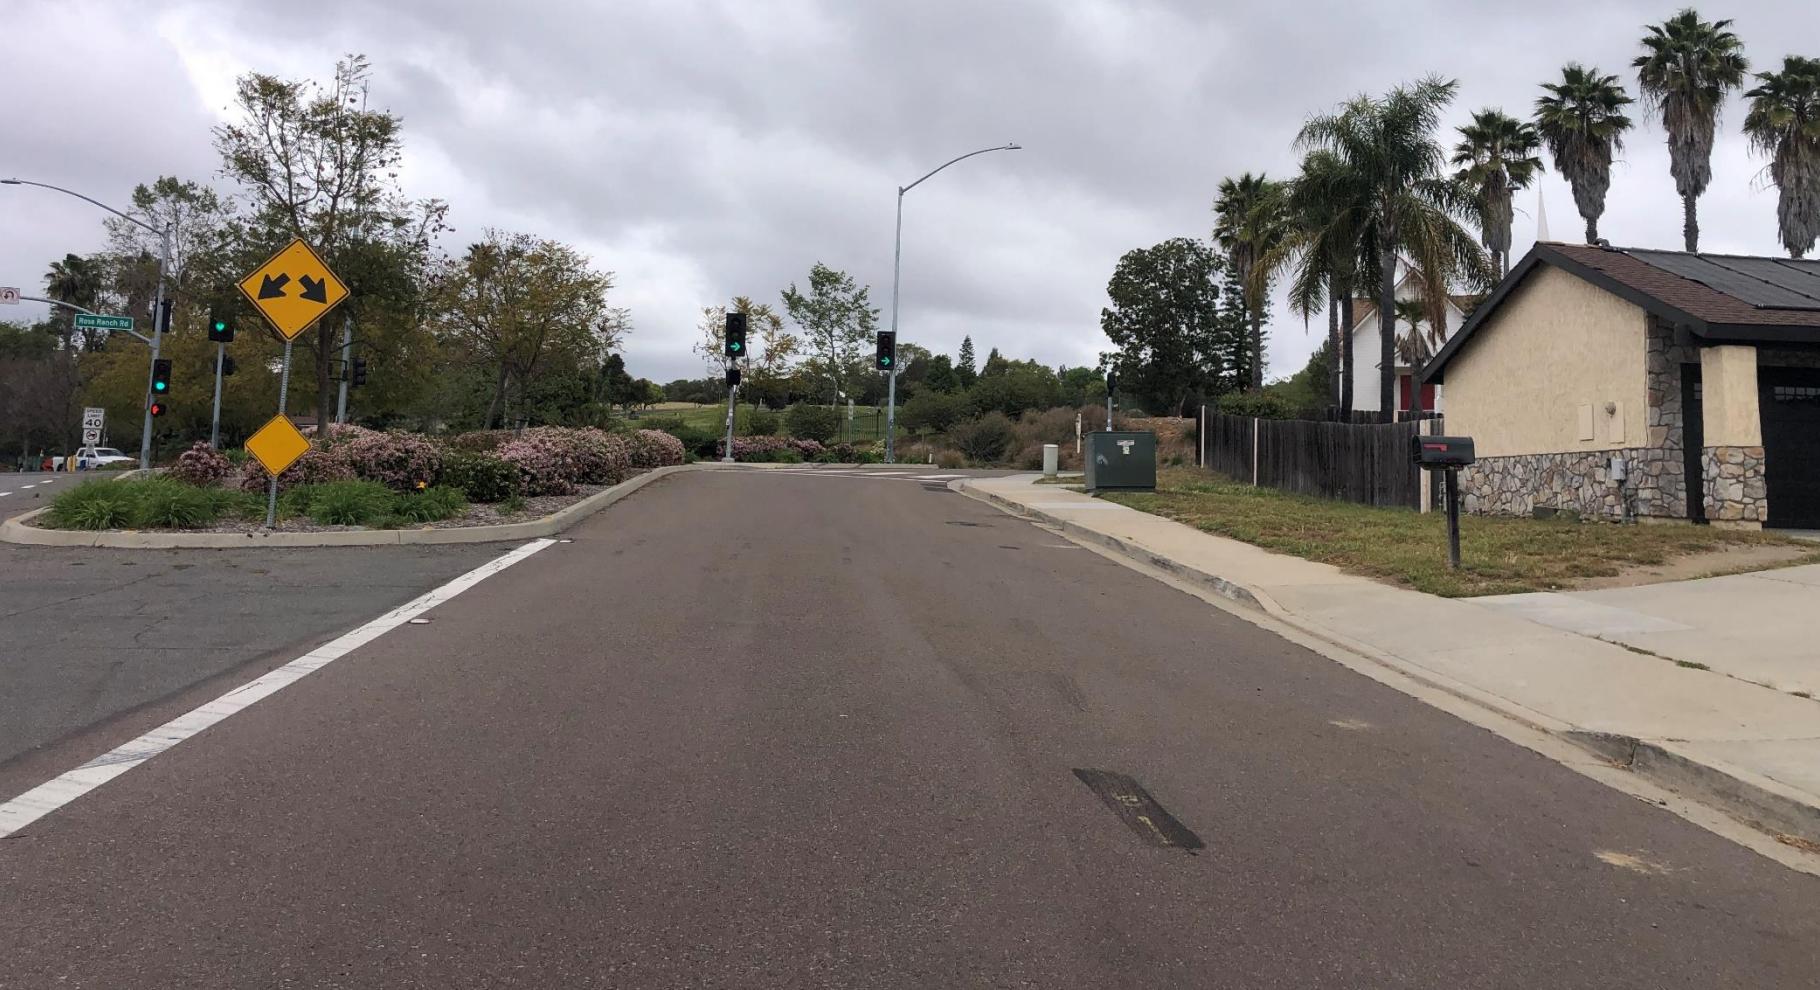
BEFORE: Looking northbound on Mulberry Drive (inside right-turn slip lane).

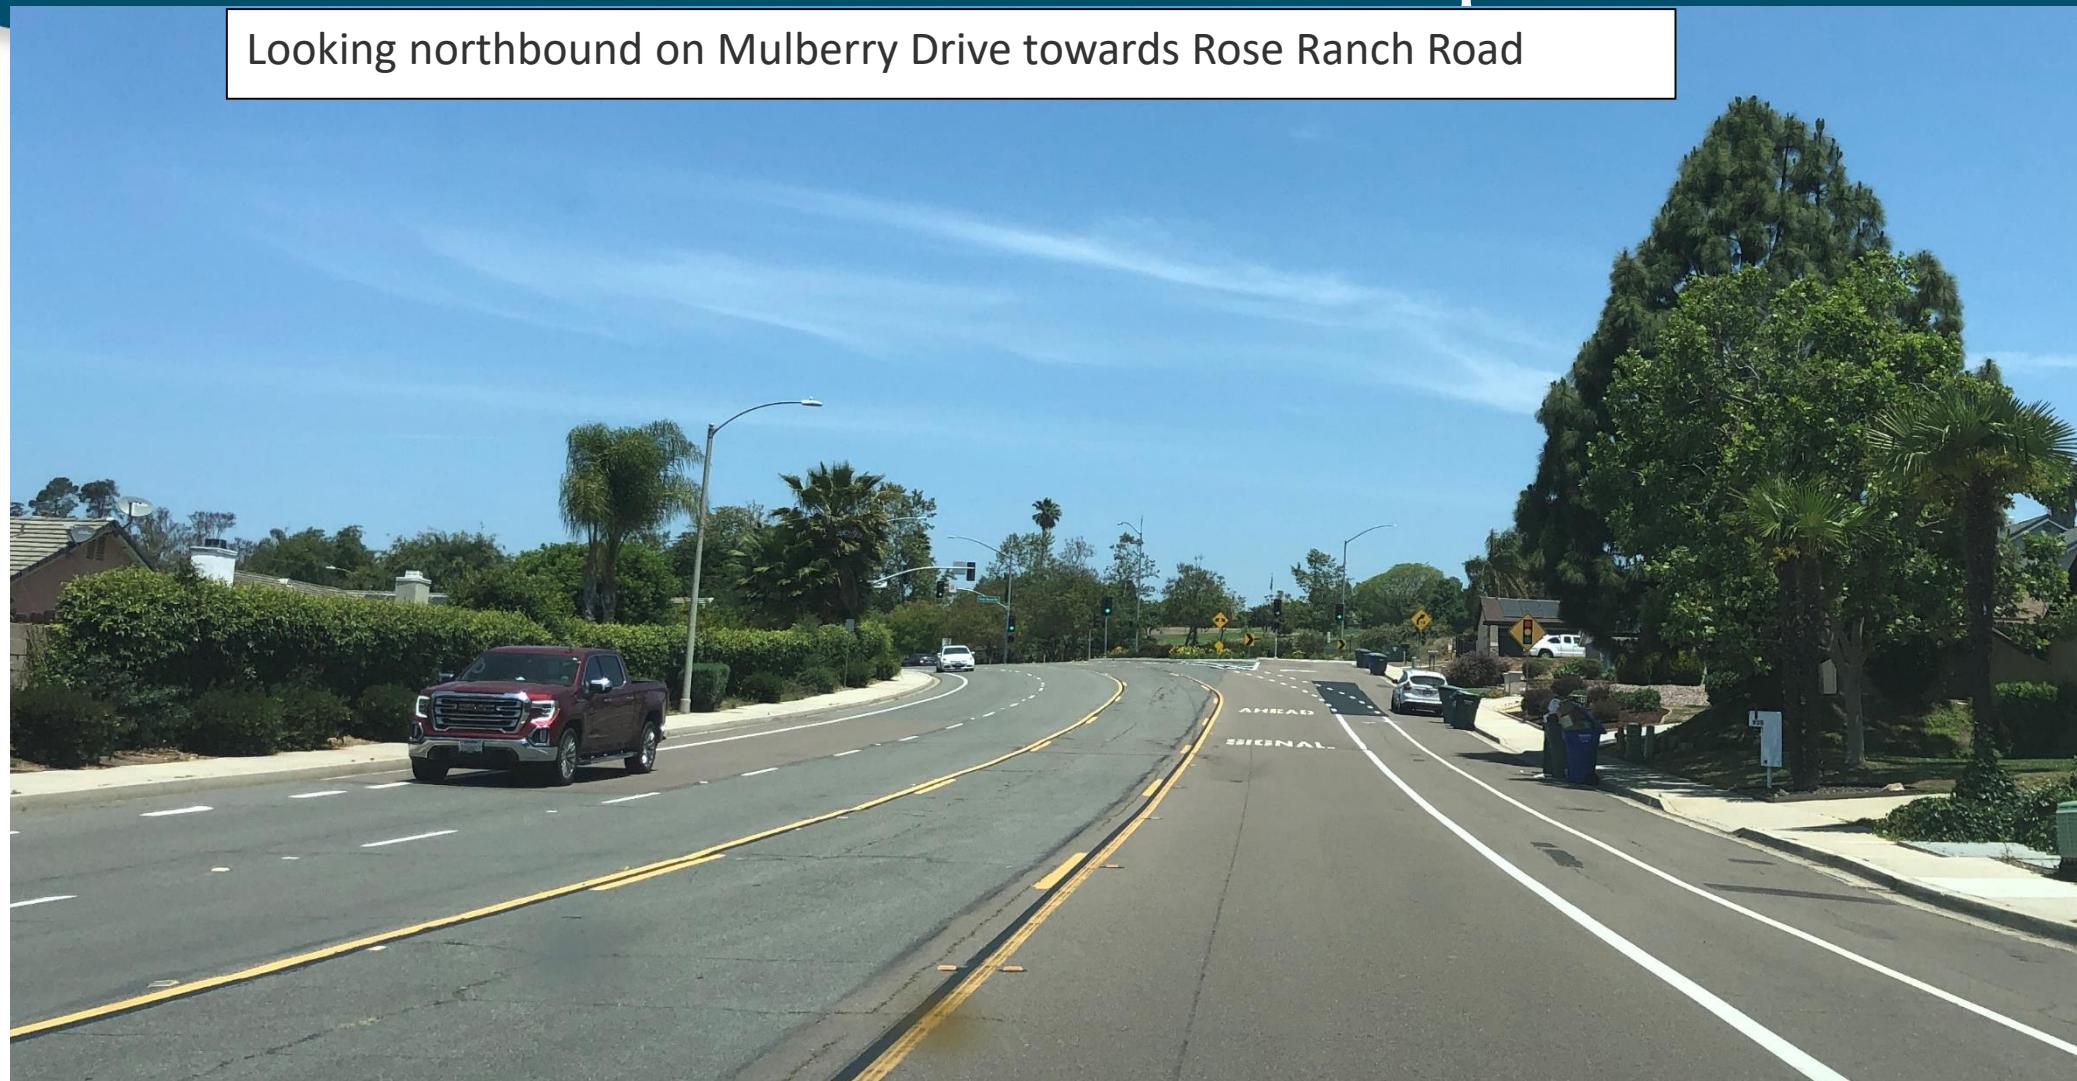
Looking northbound on Mulberry Drive towards Rose Ranch Road

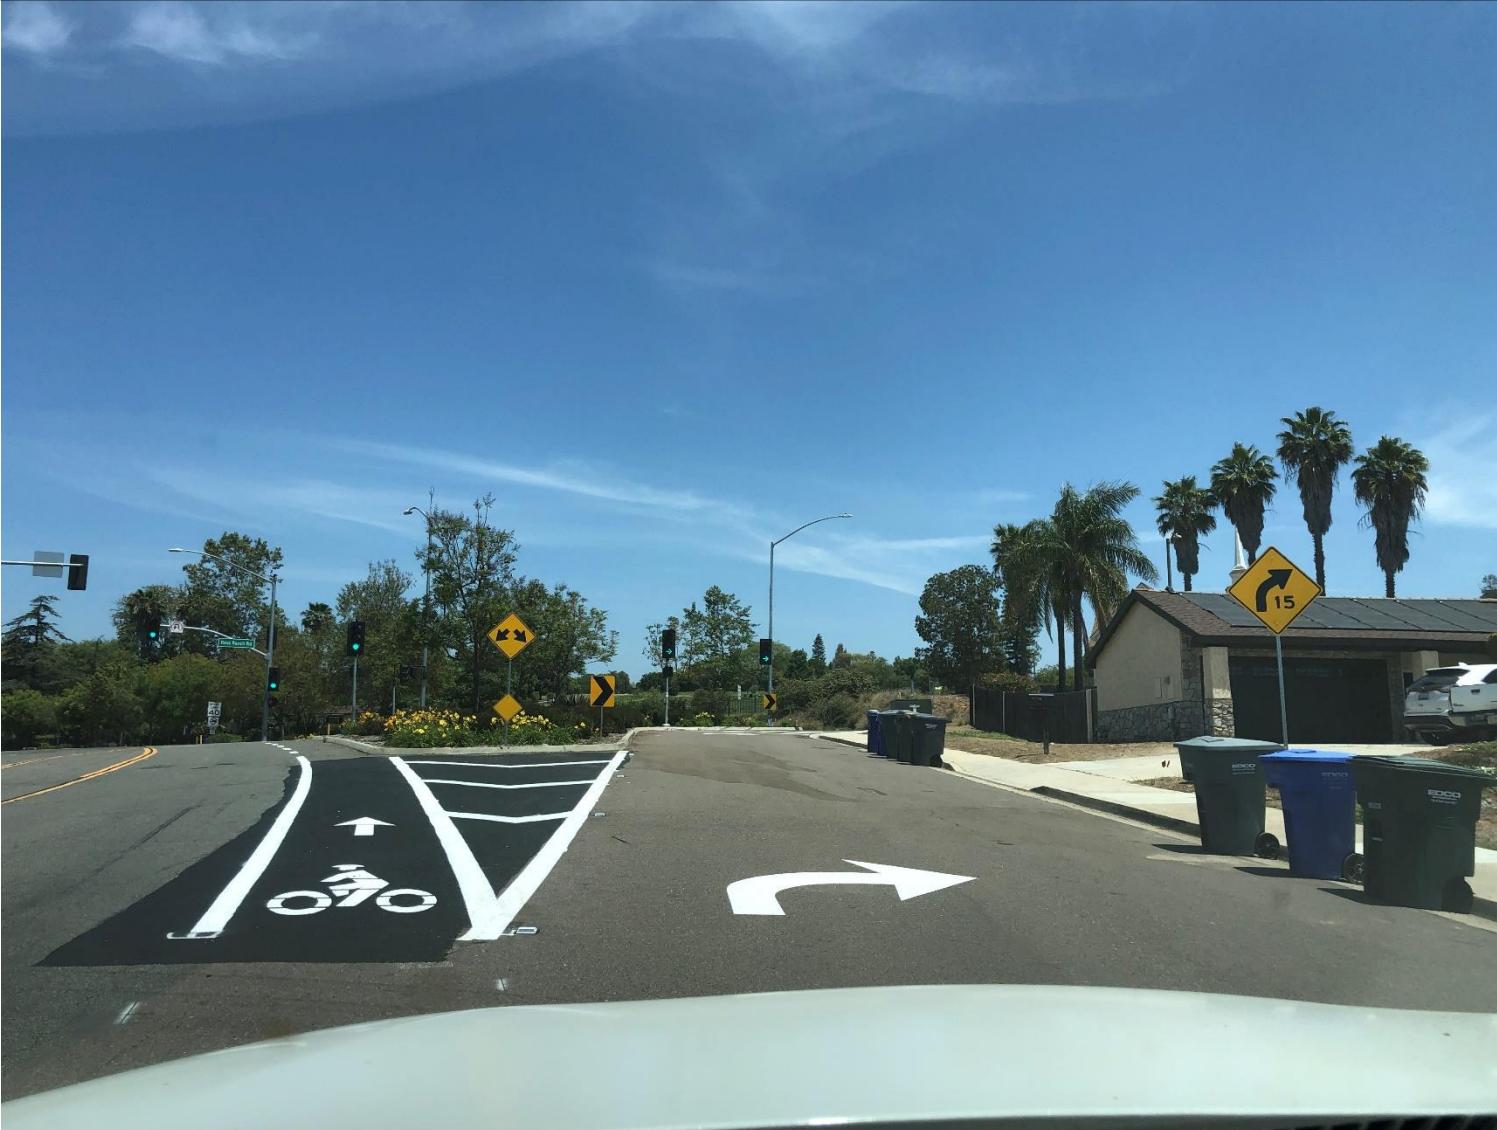
AFTER: Looking northbound on Mulberry Drive approaching right turn slip lane

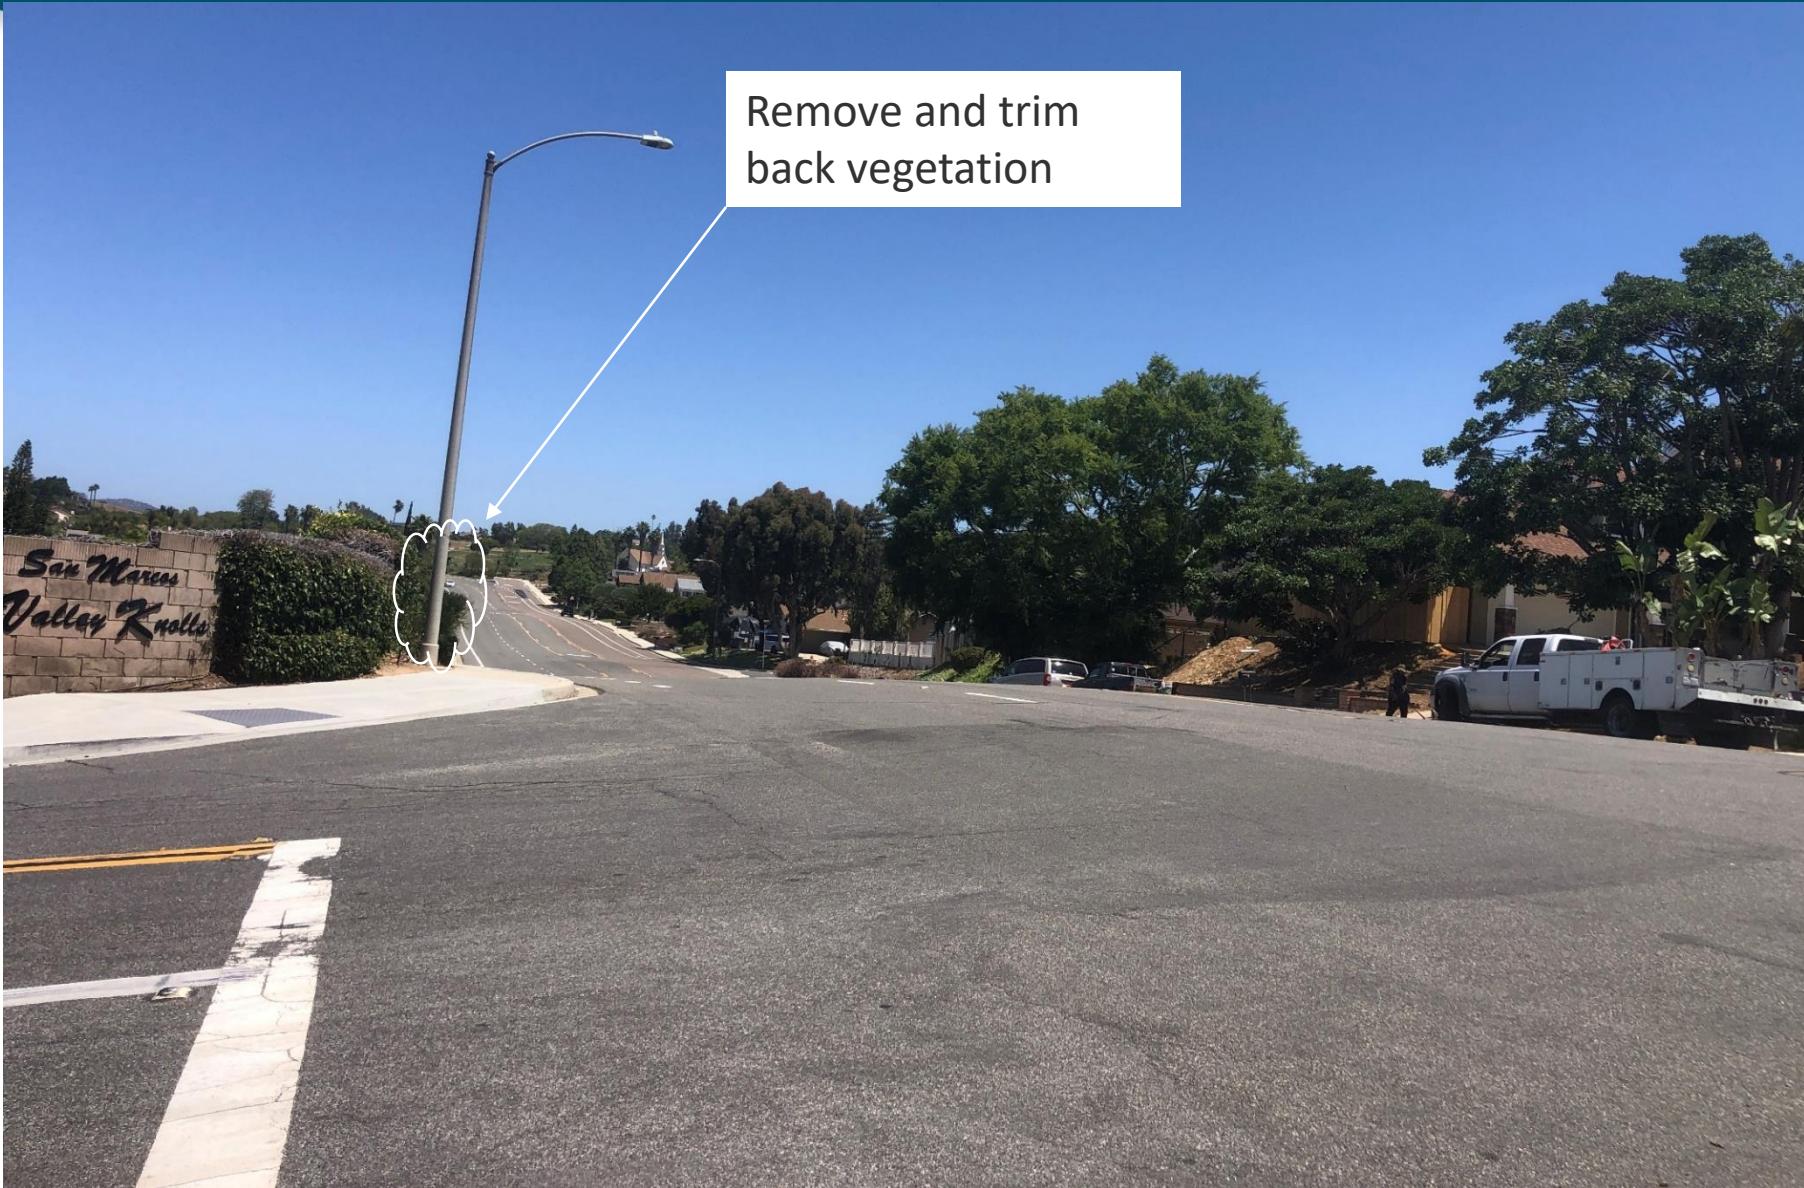
INFORMATION: Sight Distance (Vineyard @ Mulberry Drive)

- Commission Kovrig concerned about sight distance at intersection
- SD calculated at 1175 feet to the north adequate for 45 MPH (430' required)
- Recommend vegetation trimming to improve line of sight
- 8' back from the curbline; not impacting bike lane
- CA Vehicle code allows motorist to creep beyond limit line to improve line of sight
- City staff to issue work order to remove/trim back vegetation to increase SD
