TRAFFIC COMMISSION MEETING

June 2, 2021

AGENDA ITEM #7A

“NO TURN ON RED” sign- San Elijo Rd/Twin Oaks Valley Rd and Equestrian Court/Double Peak K-8 School Driveway

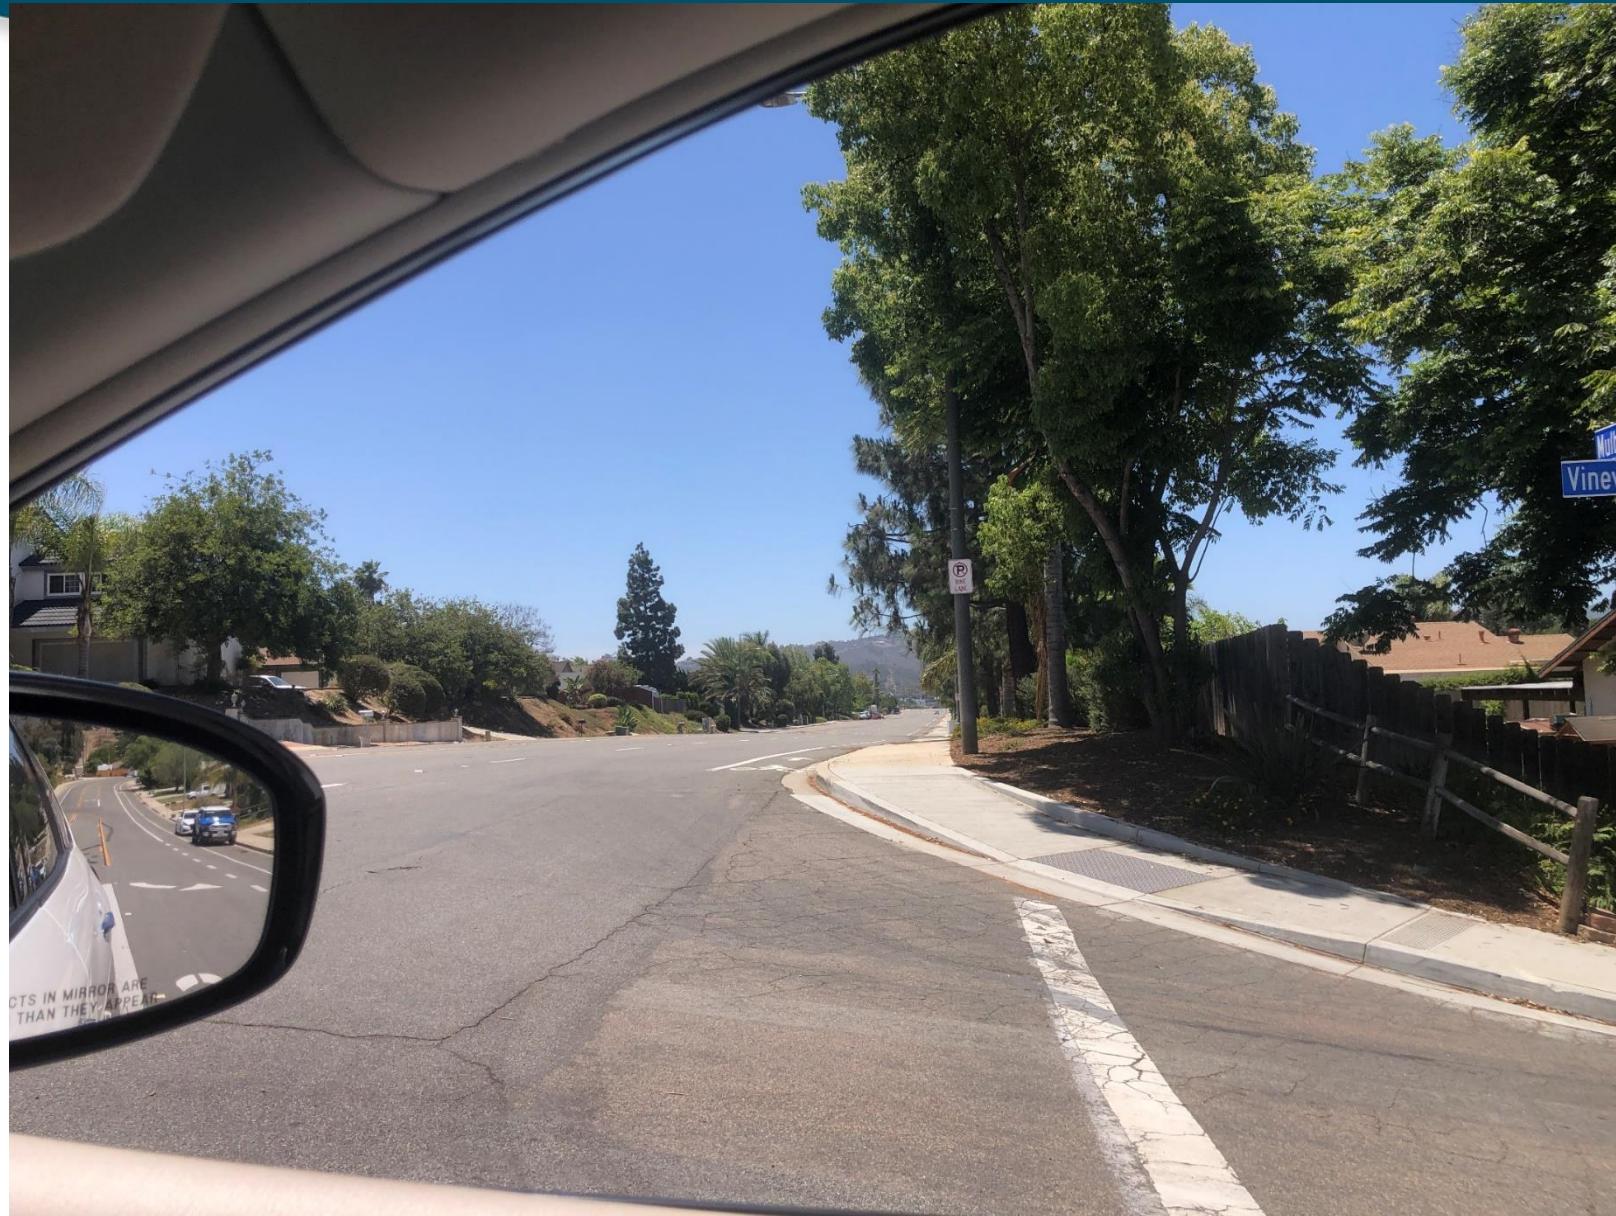
INFORMATION: Sight Distance (Vineyard @ Mulberry Drive)

-Sight distance unobstructed to the south

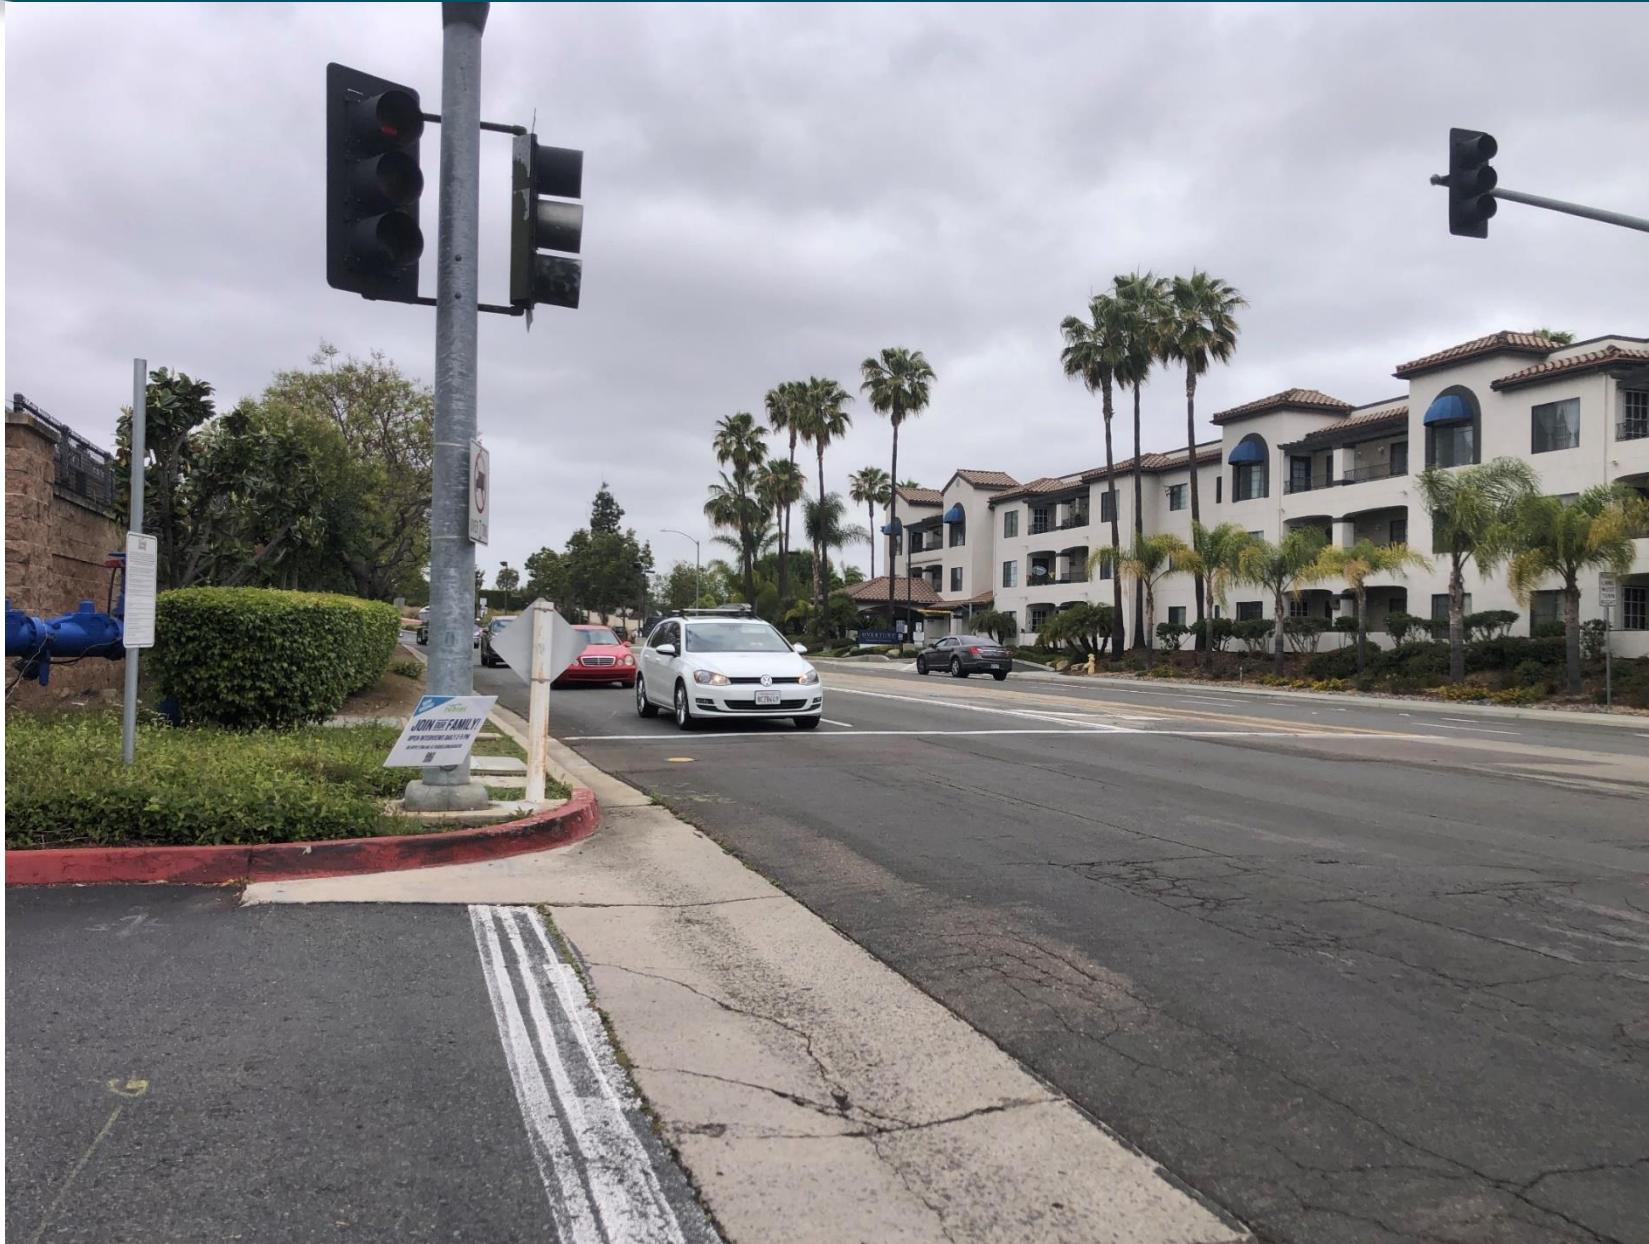
INFORMATION: Sight Distance (Avenida Ricardo/Walmart Drive @ Center Drive)

- Commissioner Erickson concerned about sight distance at intersection
- SD calculated at 283 feet to the north adequate for 25 MPH (150' required) @ limit line
- Recommend vegetation trimming to improve line of sight and removal of object marker and bollard
- New sign (OM3-R) to be installed in front of traffic signal pole (see next slide)
